Land and Soil Capability Assessment

prepared by
Sustainable Soils Management Pty Ltd

Copi Mineral Sands Project

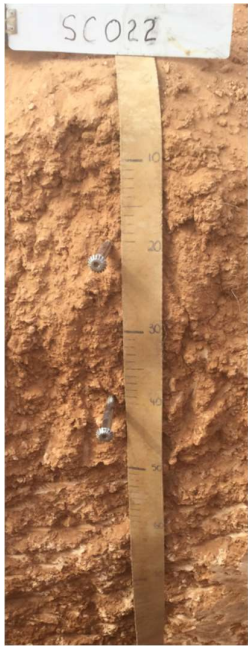
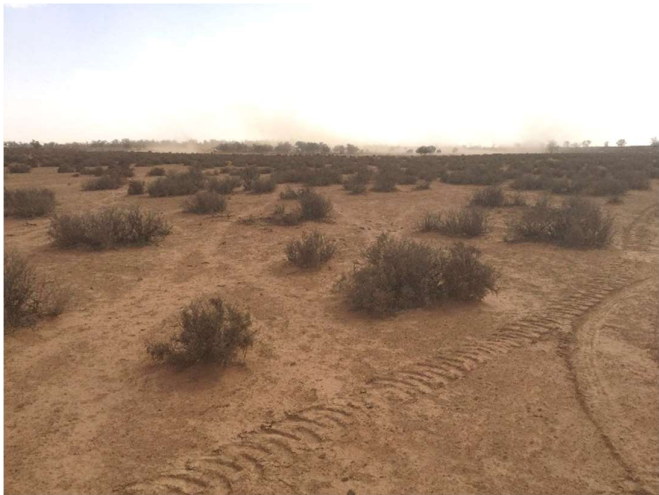
Soil Test Pit: SC022

Representative Soil Test Pit Profile Description: Dunefield and Sand Plains: Swales

Soil Test Pit SC022	Landscape view, soil test pit SC022
Australian Soil Classification Order	Calcarosol (34), Chromosol (8), Kandosol (1), Rudosol (1)
Australian Soil Classification Sub-order	Supracalcic (8), Lithocalcic (2), Hypercalcic (10), Calcic (11), Hypocalcic (3), Red (9), Stratic (1)
Representative Soil Test Pits	SC001, SC011, SC022, SC023, SC024, SC2003, SC2008, SC2009, SC2012, SC2013, SC2017, SC2018, SC2019, SC2020, SC2021, SC2022, SC2024, SC2043, SC2053, SC2054, SC2055, SC2057, SC2059, SC2060, SC2061, SC2070, SC2072, SC2073, SC2078, SC2079, SC2080, SC2081, SC2082, SC2084, SC2085, SC2091, SC2093, SC2094, SC2096, SC2099, SC2101, SC2103, SC2104, SC2105
Drainage	Poorly (7%), Imperfectly (11%), Moderately well (36%), Well (43%), Rapidly (2%)
Average ECa for Surface to 3.3 m	79 mS/m (standard deviation 32 mS/m)

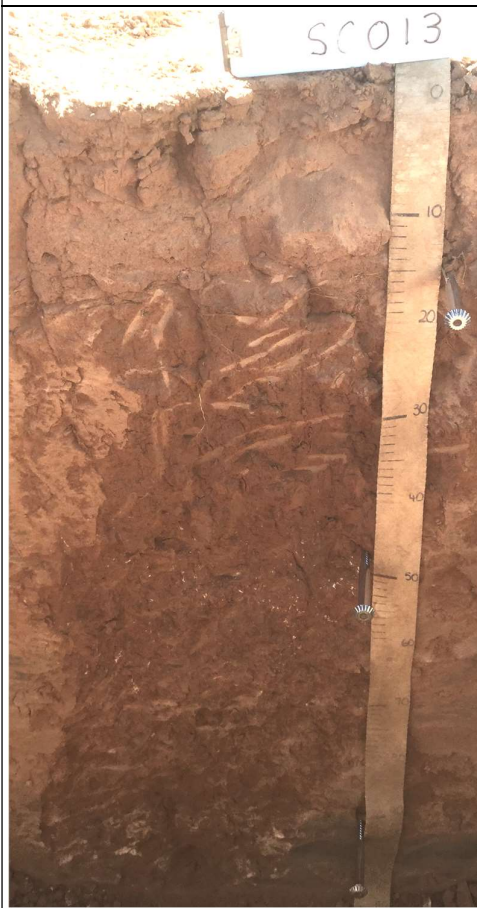
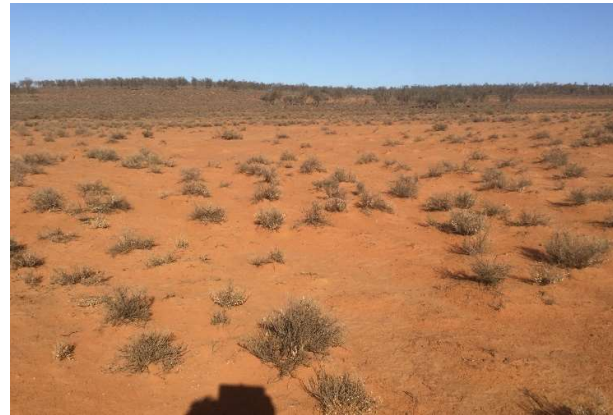
Soil Test Pit: SC013

Representative Soil Test Pit Profile Description: Blanchetown Clay

Soil Test Pit SC013	Landscape view, soil test pit SC013
Australian Soil Classification Order	Calcarosol (10), Chromosol (7), Kandosol (2)
Australian Soil Classification Sub-order	Hypercalcic (4), Supracalcic (2), Calcic (2), Hypocalcic (1), Hypergypsic (2), Red (6), Brown (2)
Representative Soil Test Pits	SC012, SC013, SC014, SC2004, SC2005, SC2006, SC2010, SC2011, SC2015, SC2023, SC2025, SC2045, SC2050, SC2052, SC2056, SC2058, SC2071, SC2076, SC2092
Drainage	Imperfectly (32%), Moderately well (53%), Well (16%)
Average ECa for Surface to 3.3 m	155 mS/m (standard deviation 49 mS/m)

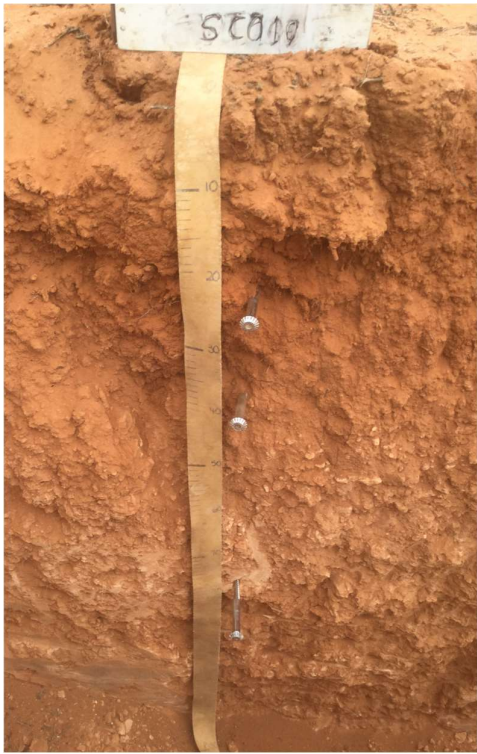
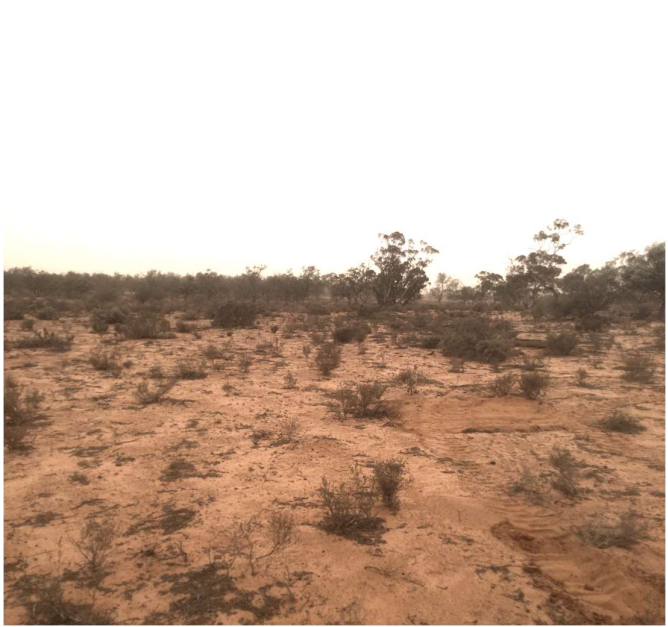
Soil Test Pit: SC010

Representative Soil Test Pit Profile Description: Lunettes

Soil Test Pit SC010	Landscape view, soil test pit SC010
Australian Soil Classification Order	Arenosol (2), Calcarosol (7)
Australian Soil Classification Sub-order	Red (2), Lithocalcic (1), Hypercalcic (2), Supracalcic (3), Calcic (1)
Representative Soil Test Pits	SC009, SC010, SC018, SC2042, SC2046, SC2048, SC2049, SC2074, SC2075
Drainage	Moderately well (44%), Well (33%), Rapidly (22%)
Average ECa for Surface to 3.3 m	65 mS/m (standard deviation 39 mS/m)

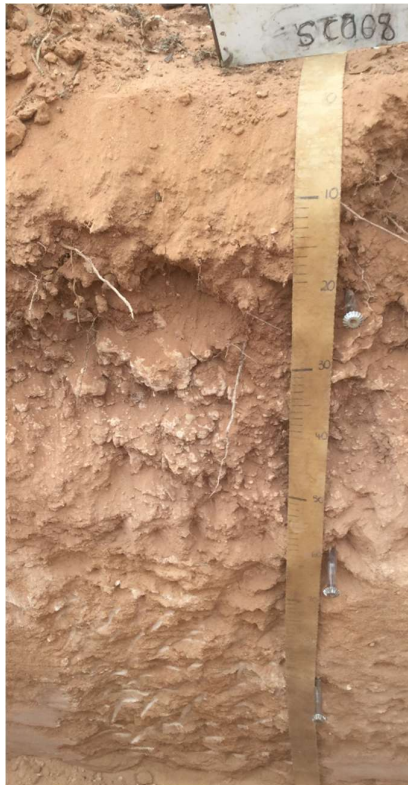
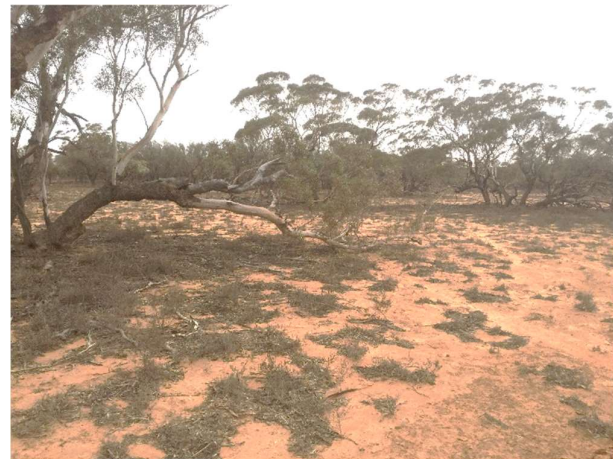
Soil Test Pit: SC008

Representative Soil Test Pit Profile Description: Lunettes

Soil Test Pit SC008	Landscape view, soil test pit SC008
Australian Soil Classification Order	Calcarosol (18), Chromosol (3), Kandosol (1)
Australian Soil Classification Sub-order	Supracalcic (3), Hypercalcic (3), Calcic (2), Hypergypsic (8), Red (3), Brown (1)
Representative Soil Test Pits	SC004, SC005, SC007, SC008, SC016, SC017, SC019, SC2001, SC2016, SC2033, SC2034, SC2035, SC2040, SC2041, SC2047, SC2062, SC2063, SC2067, SC2068, SC2090, SC2095, SC2097
Drainage	Imperfectly (5%), Moderately well (32%), Well (64%)
Average ECa for Surface to 3 m	60 mS/m (standard deviation 50 mS/m)

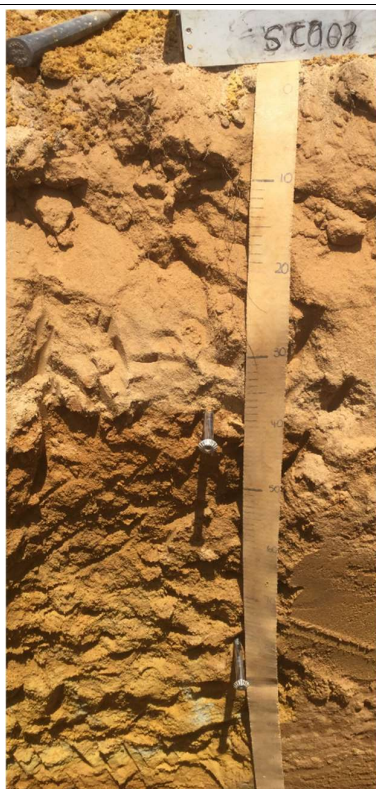
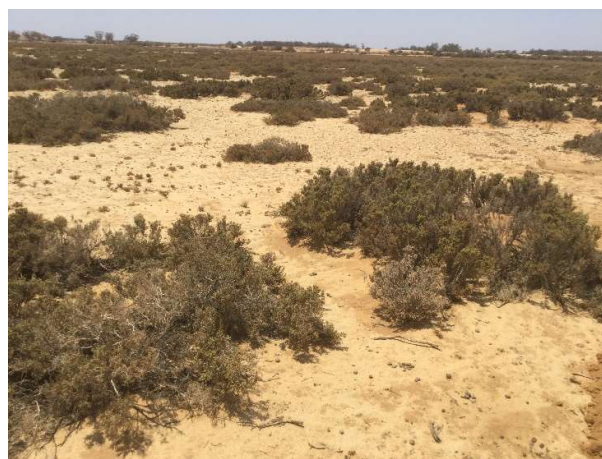
Soil Test Pit: SC002

Soil Test Pit SC002	Landscape view, soil test pit SC002
Australian Soil Classification Order	Arenosol (1), Rudosol (1), Calcarosol (1)
Australian Soil Classification Sub-order	Brown (1), Hypersalic (1), Hypocalcic (1)
Representative Soil Test Pits	SC002, SC003, SC006
Drainage	Poor (67%), Imperfect (33%)
Average ECa for Surface to 3 m	367 mS/m (standard deviation 125 mS/m)

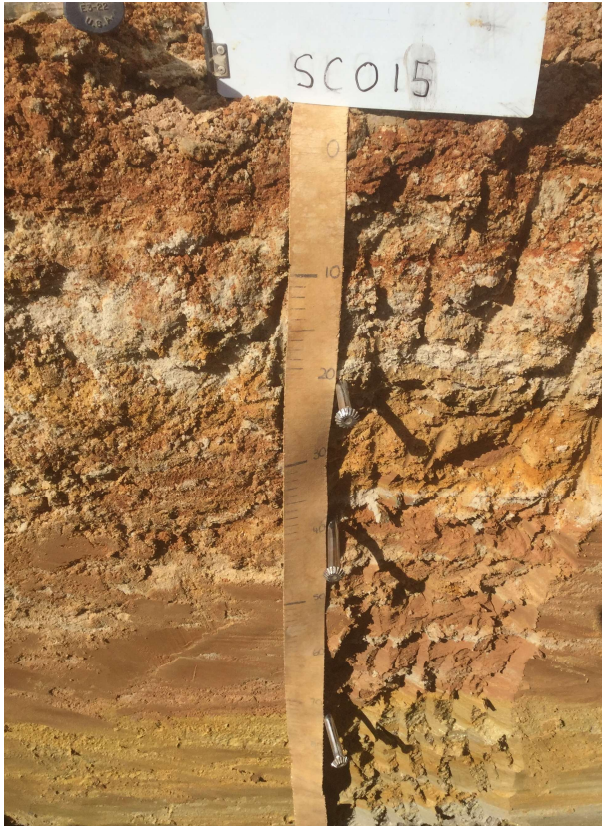
Figure 7.2. Pit SC015 showing green-grey mud at 120 cm.

Soil in the profile of SC015 contained layers of soft, buttery green-grey mud (Figure 7.2). Soil pH of this layer was 1.4 after mixing with 30% peroxide. This result is indicative rather than reliable because of the delay between sampling and testing.

The low pH after mixing with 30% peroxide and the green-grey clay depicted in Figure 7.2 means that it is possible that Potential Acid Sulphate Soil is present in some parts of the Soil Study Area. On this basis, Acid Sulphate Soil Assessment for the Soil Study Area should proceed to Step 4.

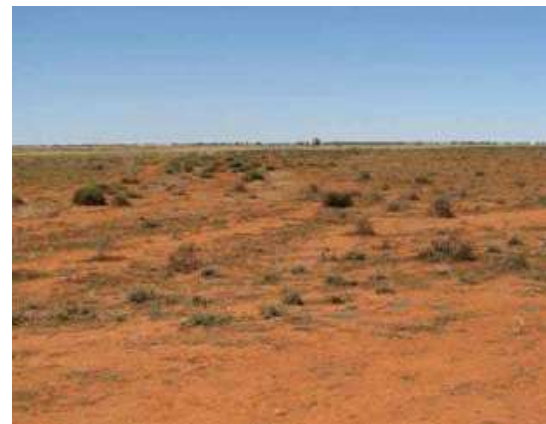
Figure 8.3. Example LSC 6 from OEH, 2012.

Mapping the majority of the Soil Study Area as LSC 6 appears to be consistent with the intent of the LSC methodology given the similarity between many of the soil assessment site photos (Appendix II) and the photo in Figure 8.3, given as a typical of LSC by OEH (2012).

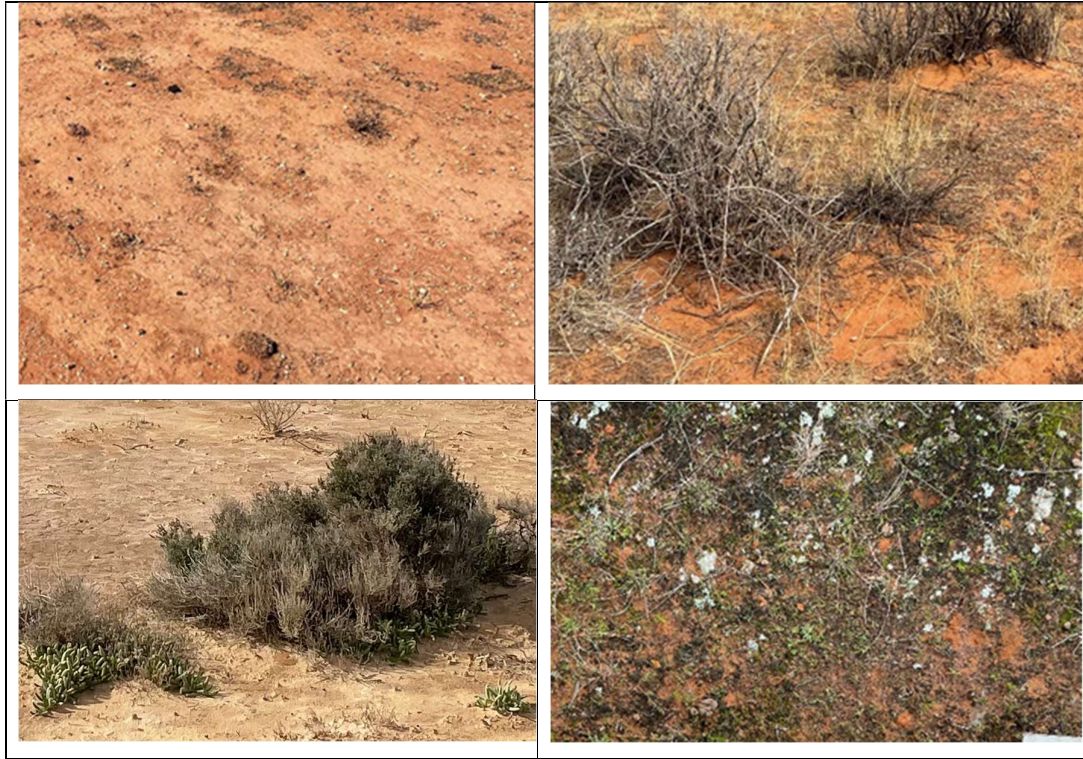
Figure 10.3. Natural surface erosion protection recorded during soil assessment. Top left: Hardset silty surface soil. Top right: sand built up around bases of blue bush shrubs with litter from annual medics and grasses. Bottom left: Pigface, samphire and poppy saltbush in extremely saline soil. Bottom right: cryptogam crust after rain.

Soil erodibility can be lowered by forming a surface crust. A range of mechanisms that stabilise the soil were recorded during the soil assessment. These include hardsetting of soil, and surface protection from plants and plant litter (Figure 10.3). Cryptogram crusts (thin crusts of mosses, lichens, algae and bacteria) were also recorded.

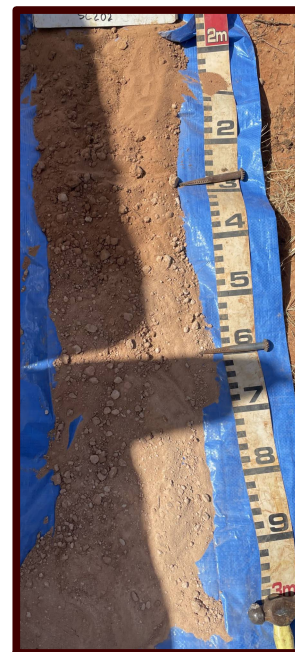
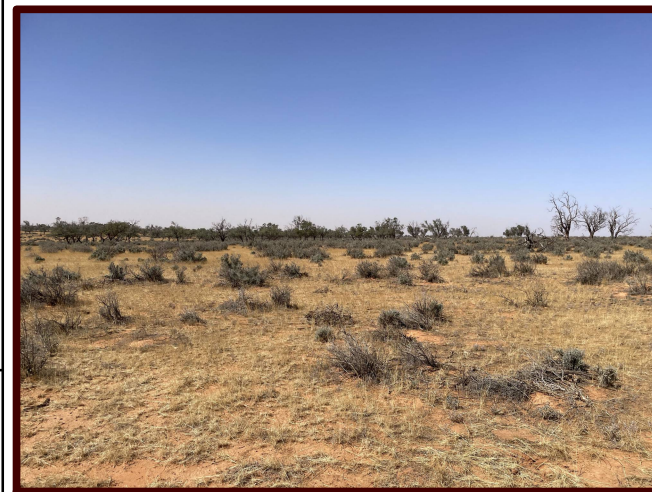
TEST HOLE SC2003

Erosion: Partly stabilised Sheet

Vegetation: Poor pearl bluebush, medic, corkscrew grass. Belah nearby

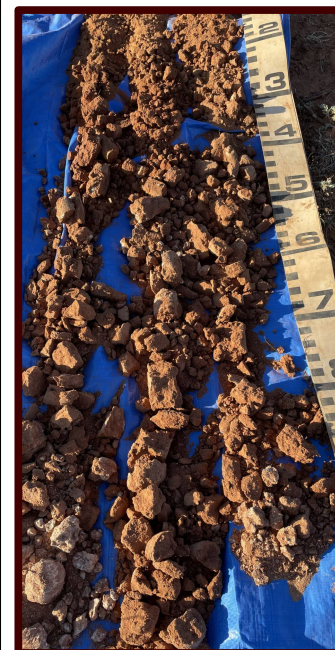
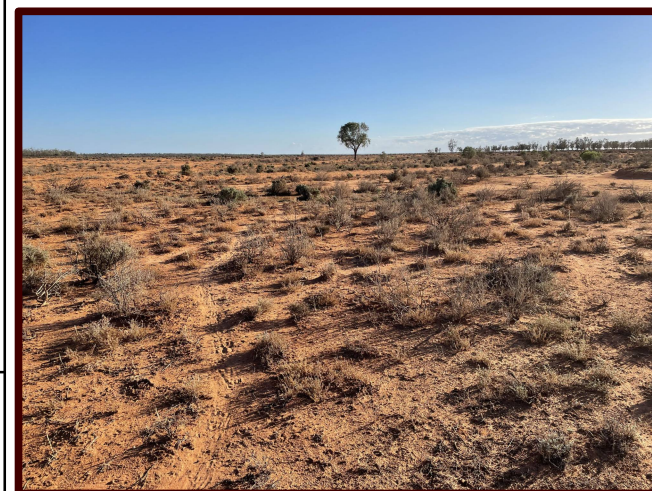
TEST HOLE SC2004

Landscape position: Upper slope
 Microrelief: No microrelief
 Erosion: Active Sheet
 Vegetation: Copperburr, medic

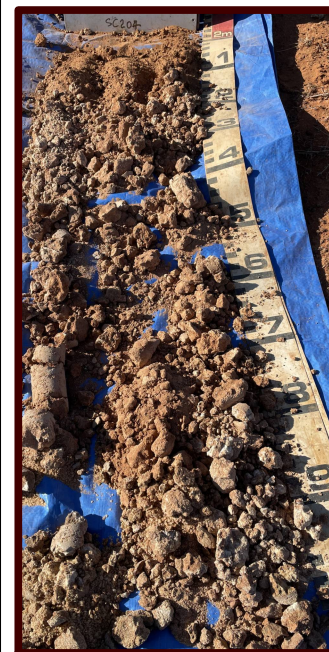
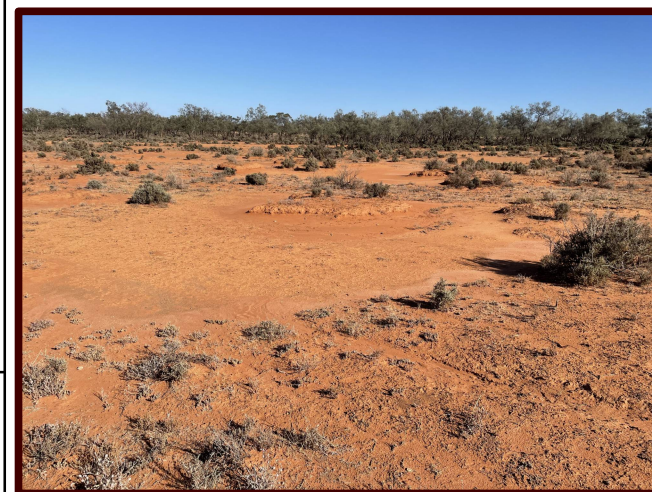
TEST HOLE SC2005

Landscape position: Midslope
 Microrelief: No microrelief
 Erosion: Active Sheet
 Vegetation: Medic, scattered pearl bluebush

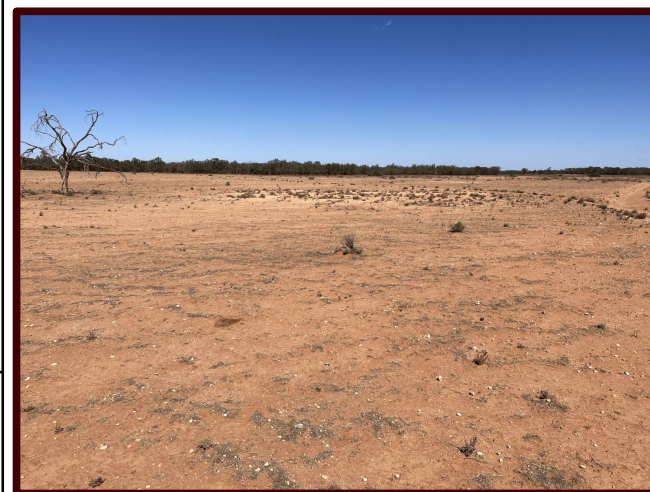
TEST HOLE SC2006

Landscape position: Midslope
 Microrelief: No microrelief
 Erosion: Active Wind
 Vegetation: Medic

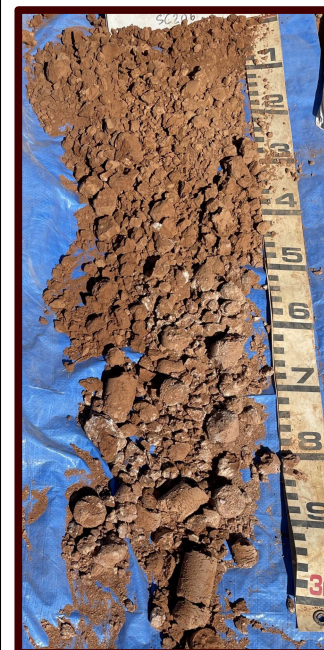
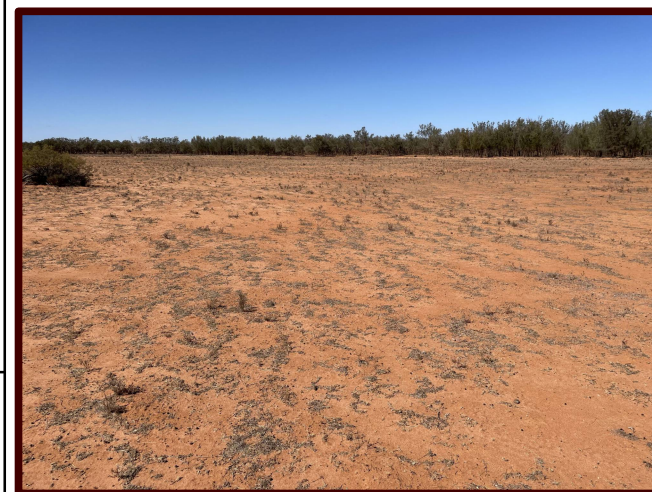
TEST HOLE SC2007

Landscape position: Upper slope
 Microrelief: No microrelief
 Erosion: Active Wind
 Vegetation: Medic

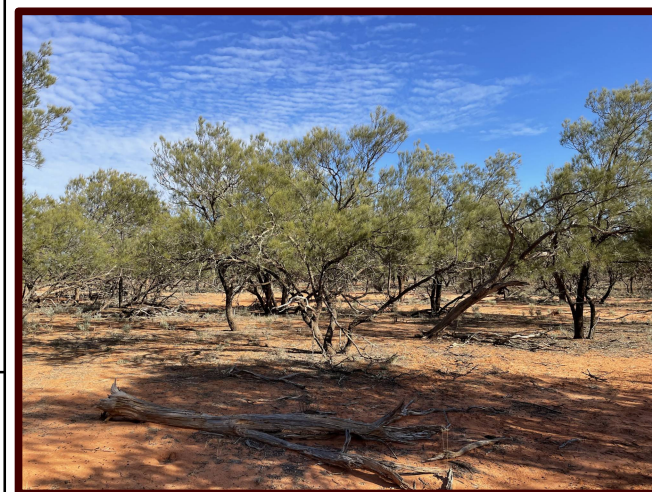
TEST HOLE SC2008

Landscape position: Midslope
 Microrelief: No microrelief
 Erosion: Active Sheet
 Vegetation: Belah, copperburr

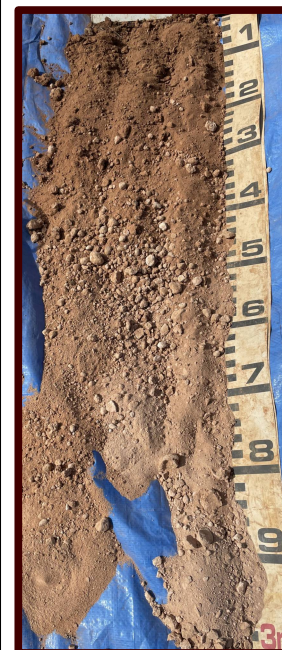
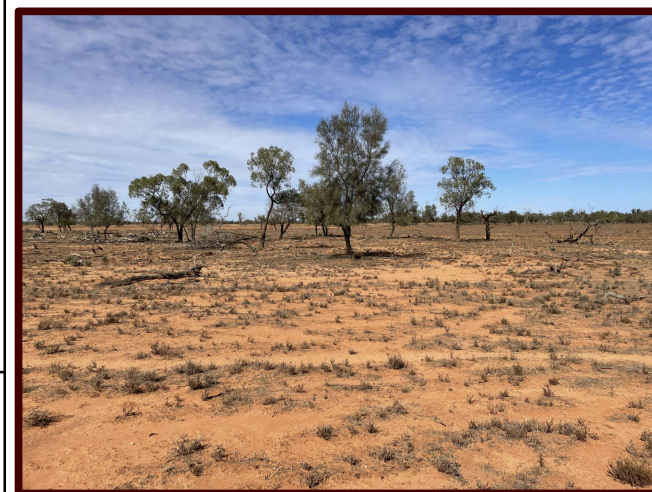
TEST HOLE SC2009

Landscape position: Upper slope
 Microrelief: No microrelief
 Erosion: Partly stabilised Sheet
 Vegetation: Medic, copperburr, few belah nearby

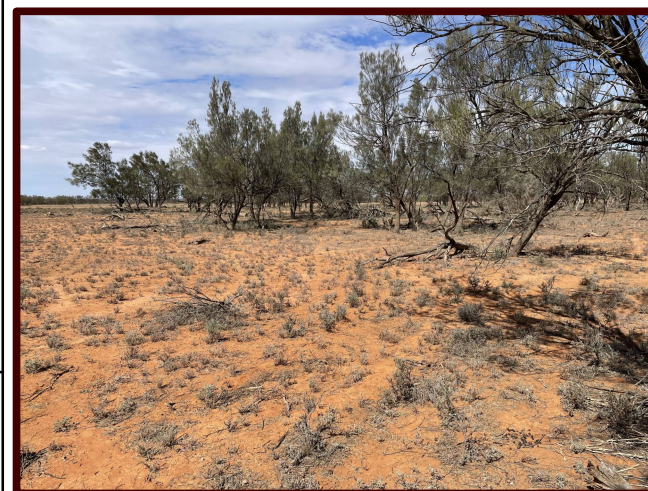
TEST HOLE SC2010

Landscape position: Crest
Microrelief: No microrelief
Erosion: Semi Active Sheet
Vegetation: Edge belah, copperburr, medic

DEPTH (centimetres)	Horizon	GRAPHIC LOG	PROFILE DESCRIPTION	Field pH	Moisture	Efferves- cence	Approximate Concretions	Field ECe (dS/m)	SAMPLE
	A		Red loamy sand with weak grade of structure. Soil is slightly dispersive, completely slakes	8.5	Dry	Slight			
	B1		Red loam, fine sandy with weak grade of structure. Soil is not dispersive, partially slakes	9	Dry	Moderate	5% Carb	8.5	
50	B2k		Red clay loam with weak grade of structure. Soil is not dispersive, completely slakes	9	Dry	Very high	80% Carb	9.2	
100			COMMENTS: Similar to SC2008. Appears to be layer rounded carbonate nodules 45 to 60. No carbonate to 25, 5% carbonate to 40, 80% carbonate to 110. Bottom of hole at 110						
150

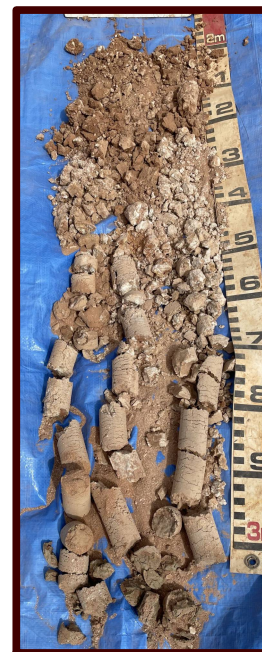
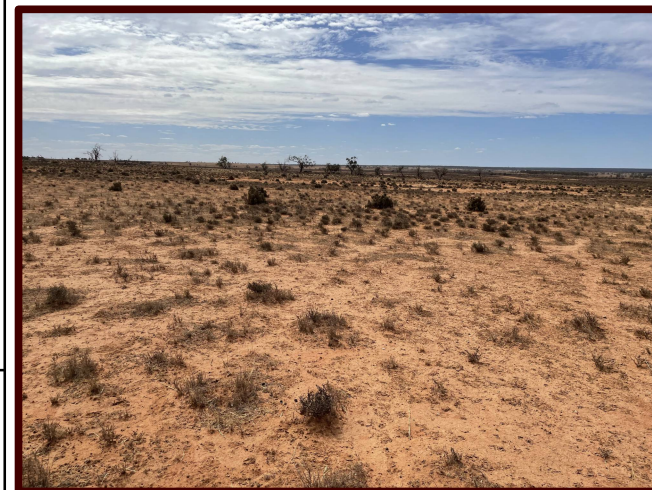
TEST HOLE SC2011

Erosion: Active Sheet

Vegetation: Medic, copperburr, few black bluebush

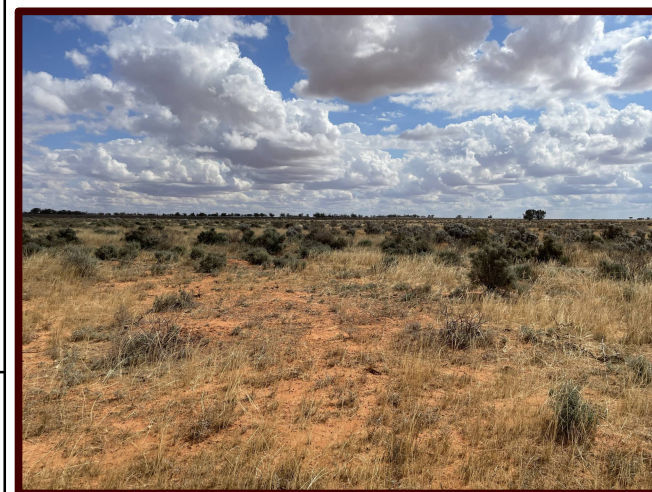
TEST HOLE SC2012

Landscape position: Hillock
 Microrelief: No microrelief
 Erosion: Partly stabilised Wind
 Vegetation: Pearl bluebush, cannonball, medic, corkscrew grass.

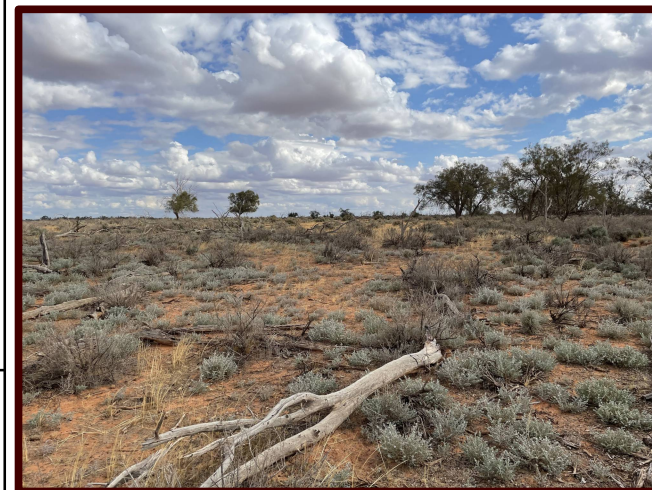
TEST HOLE SC2013

Date Excavated: 8/4/22 Australian Soil Class: Hypocalcic Calcarosol Geology: Woorinen Formation
 Logged by: PJH Datum: WGS 84 Annual Crop Rootzone (cm): 60 Landuse: Rangeland Grazing
 Easting: 538641 Northing: 6276196 Plant Available Water (mm): 79 Surface condition: Surface Crust
 Surface Elevation(m): 60.4 Drainage: Well drained Surface gravel: None
 Equipment: Christie Estimated Permeability: 50 to 500 mm/day Outcrop: None

Landscape position: Upper slope
 Microrelief: No microrelief
 Erosion: Partly stabilised Wind
 Vegetation: Dead pearl bluebush, corkscrew grass, medic

DEPTH (centimetres)	Horizon	GRAPHIC LOG	PROFILE DESCRIPTION	Field pH	Moisture	Efferves- cence	Approximate Concretions	Field ECe (dS/m)	SAMPLE
	A1		Red sandy loam with weak grade of subangular blocky structure. Soil is slightly dispersive, completely slakes	8	Dry	Very high			
50	A3		Red silt loam with moderate grade of angular blocky structure. Soil is slightly dispersive, completely slakes	8	Dry	Very high		0.9	
	B1k		Red sandy clay loam with weak grade of polyhedral structure. Soil is not dispersive, partially slakes	8.5	Dry	Very high	20% Carb		
100	B2		Red sandy clay loam with moderate grade of angular blocky structure. Soil is not dispersive, partially slakes	8.5	Dry	Very high	5% Carb	8.5	
150			COMMENTS: Sand built up around dead blue bush. Surface condition - weak crust. Bottom of hole at 130

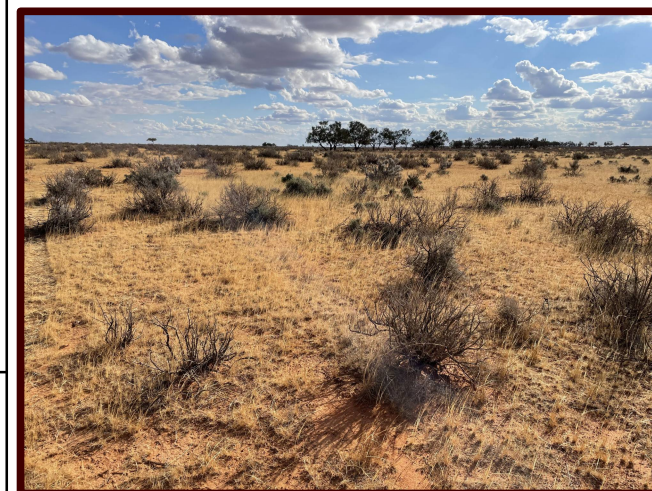
TEST HOLE SC2014

Date Excavated: 9/4/22 Australian Soil Class: Red Kandosol Geology: Yamba Formation - saline lakes
 Logged by: PJH Datum: WGS 84 Annual Crop Rootzone (cm): 70 Landuse: Rangeland Grazing
 Easting: 533866 Northing: 6280534 Plant Available Water (mm): 63 Surface condition: Surface Flake
 Surface Elevation(m): 27.4 Drainage: Imperfectly drained Surface gravel: None
 Equipment: Christie Estimated Permeability: 50 to 500 mm/day Outcrop: None

DEPTH (centimetres)	Horizon	GRAPHIC LOG	PROFILE DESCRIPTION	Field pH	Moisture	Efferves- cence	Approximate Concretions	Field ECe (dS/m)	SAMPLE
	A1		Brown loamy sand with weak grade of polyhedral structure. Soil is not dispersive, partially slakes, has a moderate SOILpak score and has many roots present.	8	Dry	High			
	A3		Red loamy sand with weak grade of subangular blocky structure. Soil is not dispersive, partially slakes, has a poor to moderate SOILpak score and has many roots present.	8	Dry	High		0.6	
50									
	B1		Red sandy loam with weak grade of polyhedral structure. Soil is not dispersive, doesn't slake, has a moderate SOILpak score and has few roots present.	8	Dry	Moderate	2% Carb		
	B2		Brown loam, fine sandy with weak grade of polyhedral structure. With 30% mottle. Soil is not dispersive, doesn't slake, has a poor to moderate SOILpak score and has few roots present.	8	Trace	Nil	5% Gyp	0.5

100									
			COMMENTS: Small levee in depression. Landform element - Levee. Bottom of hole at 140						
150

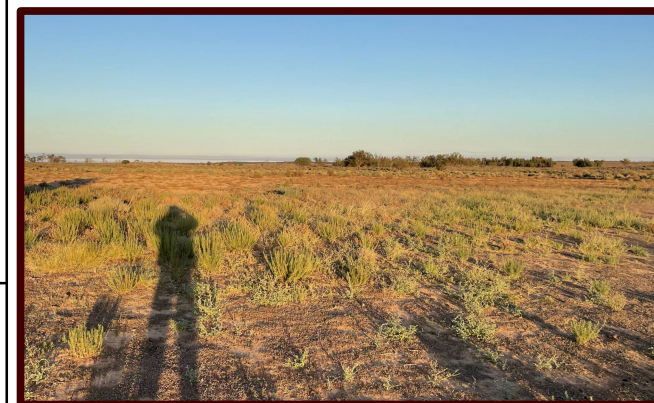
TEST HOLE SC2015

Date Excavated: 9/4/22 Australian Soil Class: Hypergyptic Calcarosol Geology: Yamba Formation
 Logged by: PJH Datum: WGS 84 Annual Crop Rootzone (cm): 40 Landuse: Rangeland Grazing
 Easting: 529566 Northing: 6283271 Plant Available Water (mm): 34 Surface condition: Cryptogram crust
 Surface Elevation(m): 27.9 Drainage: Imperfectly drained Surface gravel: None
 Equipment: Christie Estimated Permeability: 5 to 50 mm/day Outcrop: None

Landscape position: Lower Slope
 Microrelief: No microrelief
 Erosion: Stabilised
 Vegetation: Corkscrew grass, saltbush?

DEPTH (centimetres)	Horizon	GRAPHIC LOG	PROFILE DESCRIPTION	Field pH	Moisture	Efferves- cence	Approximate Concretions	Field ECe (dS/m)	SAMPLE
	A1		Red loamy sand with weak grade of subangular blocky structure. Soil is not dispersive, partially slakes	8.5	Dry	Nil			
	A3		Red loamy sand with weak grade of angular blocky structure. Soil is not dispersive, partially slakes	8.5	Dry	Nil		9.6	
50	B21y		Red loam with moderate grade of polyhedral structure. Soil is not dispersive, doesn't slake	7	Dry	Very high	80% Gyp		
	B22y		Red sandy clay with strong grade of polyhedral structure. Soil is not dispersive, partially slakes	8	Trace	Nil	80% Gyp	13.3	
100									
150			COMMENTS: Edge small depression. Bottom of hole at 140

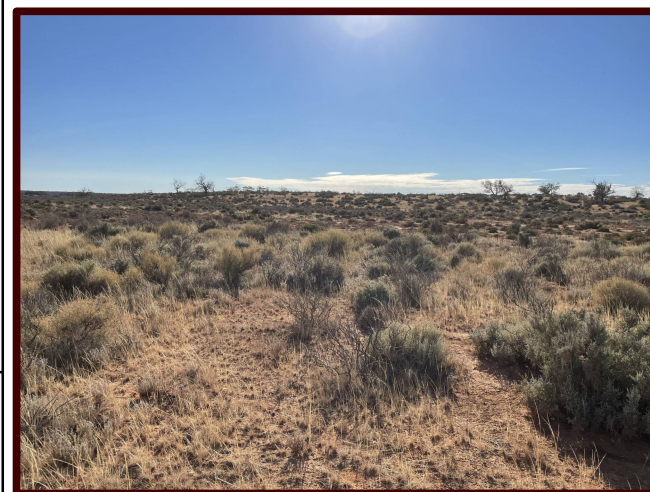
TEST HOLE SC2016

Date Excavated: 9/4/22 Australian Soil Class: Hypergyptic Calcarosol Geology: Aeolian lunette with kopi
 Logged by: PJH Datum: WGS 84 Annual Crop Rootzone (cm): 50 Landuse: Rangeland Grazing
 Easting: 529691 Northing: 6283126 Plant Available Water (mm): 49 Surface condition: Surface Crust
 Surface Elevation(m): 29.3 Drainage: Well drained Surface gravel: None
 Equipment: Christie Estimated Permeability: 5 to 50 mm/day Outcrop: None

Landscape position: Upper slope
 Microrelief: No microrelief
 Erosion: Partly stabilised Sheet
 Vegetation: Pearl bluebush, medic

DEPTH (centimetres)	Horizon	GRAPHIC LOG	PROFILE DESCRIPTION	Field pH	Moisture	Efferves- cence	Approximate Concretions	Field ECe (dS/m)	SAMPLE
	A1		Red sandy loam with weak grade of subangular blocky structure. Soil is not dispersive, completely slakes	7	Dry	Nil			
	A3		Red loam, fine sandy with weak grade of polyhedral structure. Soil is not dispersive, partially slakes	8	Dry	Nil		6.2	
50	B22y		Red silt loam with weak grade of polyhedral structure. Soil is not dispersive, completely slakes	8	Dry	Nil	80% Gyp		
100	B23y		Brown silt loam with weak grade of polyhedral structure. Soil is not dispersive, completely slakes	8	Dry	Nil	80% Gyp	15	
150			COMMENTS: Surface 20% cryptogram crust, 80% weak surface crust. Bottom of hole at 140

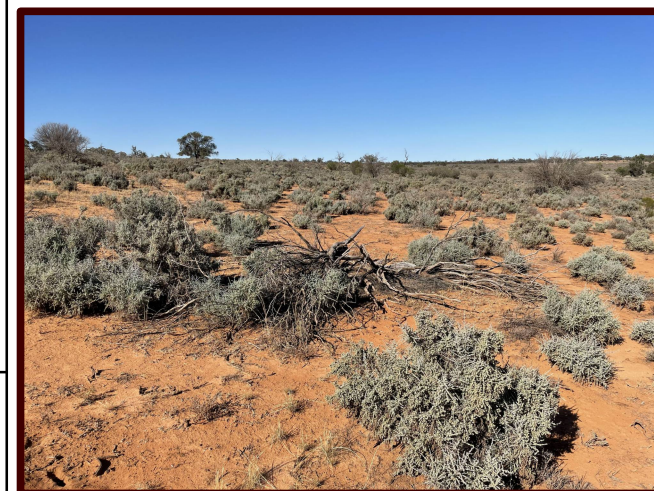
TEST HOLE SC2017

Date Excavated: 9/4/22 Australian Soil Class: Calcic Calcarosol Geology: Aeolian sand plain
Logged by: PJH Datum: WGS 84 Annual Crop Rootzone (cm): 50 Landuse: Rangeland Grazing
Easting: 531395 Northing: 6282191 Plant Available Water (mm): 60 Surface condition: Cryptogram crust
Surface Elevation(m): 52.3 Drainage: Moderately well drained Surface gravel: None
Equipment: Christie Estimated Permeability: 5 to 50 mm/day Outcrop: None

DEPTH (centimetres)	Horizon	GRAPHIC LOG	PROFILE DESCRIPTION	Field pH	Moisture	Efferves- cence	Approximate Concretions	Field ECe (dS/m)	SAMPLE
	A

Red silty clay loam with strong grade of polyhedral structure. Soil is not dispersive, completely slakes	7.5	Trace	Nil	50% Gyp	16	
150			COMMENTS: Elevated plain. Bottom of hole at 110

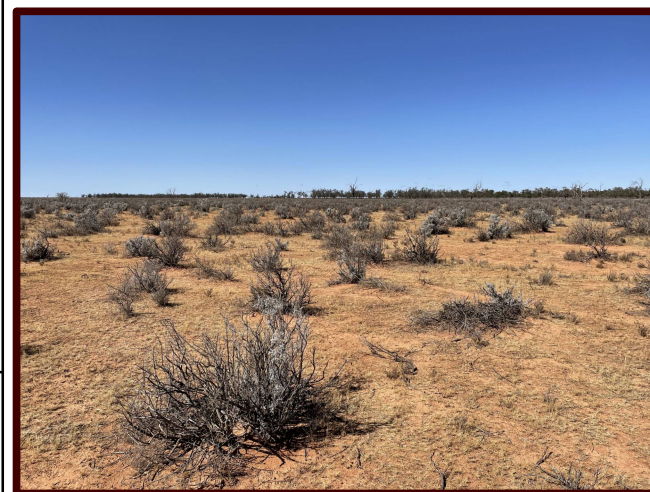
TEST HOLE SC2018

Date Excavated: 9/4/22 Australian Soil Class: Hypercalcic Calcarosol Geology: Aeolian sand plain
 Logged by: PJH Datum: WGS 84 Annual Crop Rootzone (cm): 60 Landuse: Rangeland Grazing
 Easting: 531691 Northing: 6282020 Plant Available Water (mm): 70 Surface condition: Surface Crust
 Surface Elevation(m): 54.1 Drainage: Imperfectly drained Surface gravel: None
 Equipment: Christie Estimated Permeability: 5 to 50 mm/day Outcrop: None

DEPTH (centimetres)	Horizon	GRAPHIC LOG	PROFILE DESCRIPTION	Field pH	Moisture	Efferves- cence	Approximate Concretions	Field ECe (dS/m)	SAMPLE
	A11		Red sandy loam with weak grade of subangular blocky structure. Soil is not dispersive, completely slakes	7.5	Dry	High			
	A12		Red sandy loam with moderate grade of polyhedral structure. Soil is not dispersive, completely slakes	7.5	Dry	High		2	
50	B22tk		Red light clay with strong grade of polyhedral structure. Soil is not dispersive, completely slakes	7.5	Dry	High	20% Carb		
	B23tk		Red light clay with strong grade of angular blocky structure. Soil is slightly dispersive, completely slakes	8.5	Dry	High	10% Carb	3.7	
100									
150			COMMENTS: Surface 50% surface crust, 50% loose. Foot of ridge. Bottom of hole at 140

Landscape position: Lower Slope
 Microrelief: No microrelief
 Erosion: Partly stabilised Wind
 Vegetation: Corkscrew grass, medic, copperburr, scattered dead pearl bluebush

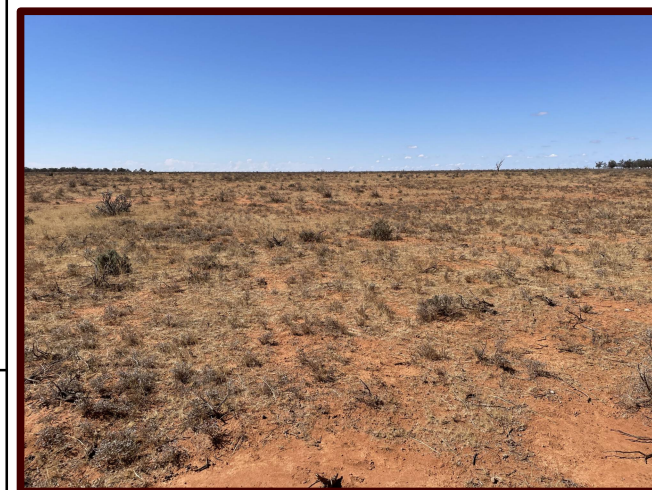
TEST HOLE SC2019

Date Excavated: 9/4/22 Australian Soil Class: Calcic Calcarosol Geology: Aeolian sand plain
 Logged by: PJH Datum: WGS 84 Annual Crop Rootzone (cm): 50 Landuse: Rangeland Grazing
 Easting: 531695 Northing: 6281567 Plant Available Water (mm): 61 Surface condition: Loose
 Surface Elevation(m): 56.4 Drainage: Moderately well drained Surface gravel: None
 Equipment: Christie Estimated Permeability: 5 to 50 mm/day Outcrop: None

DEPTH (centimetres)	Horizon	GRAPHIC LOG	PROFILE DESCRIPTION	Field pH	Moisture	Efferves- cence	Approximate Concretions	Field ECe (dS/m)	SAMPLE
	A11		Red sandy loam with weak grade of subangular blocky structure. Soil is not dispersive, partially slakes	8	Dry	Slight			
	A12		Red silt loam with weak grade of subangular blocky structure. Soil is not dispersive, completely slakes	8	Dry	Very high		0.8	
50	B21k		Red fine sandy clay loam with moderate grade of polyhedral structure. Soil is not dispersive, completely slakes	8.5	Dry	Very high	20% Carb		
100	B22k		Red sandy clay loam with moderate grade of polyhedral structure. Soil is slightly dispersive, completely slakes	8.5	Dry	High	20% Carb	8.4	
150			COMMENTS: Sand built up around Bluebush. Surface 60% loose, 40% crust. Top of slope down to lake.

Landscape position: Crest
 Microrelief: No microrelief
 Erosion: Partly stabilised Sheet
 Vegetation: Pearl bluebush, saltbush, medic, small corkscrew grass

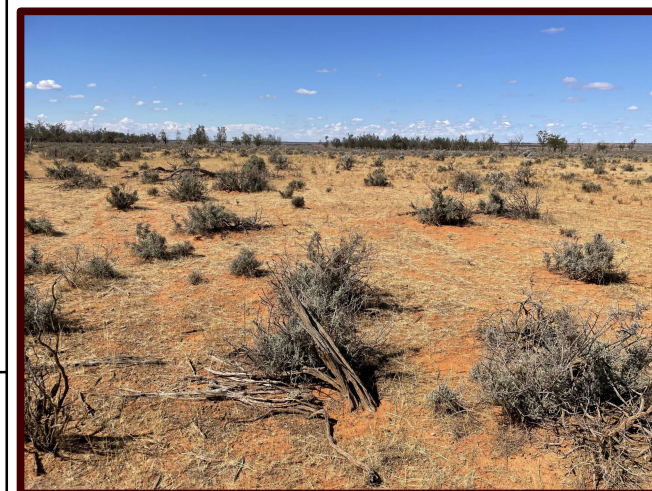
TEST HOLE SC2020

Date Excavated: 9/4/22 Australian Soil Class: Calcic Calcarosol Geology: Aeolian sand plain
 Logged by: PJH Datum: WGS 84 Annual Crop Rootzone (cm): 70 Landuse: Rangeland Grazing
 Easting: 531973 Northing: 6281386 Plant Available Water (mm): 57 Surface condition: Loose
 Surface Elevation(m): 53.4 Drainage: Imperfectly drained Surface gravel: None
 Equipment: Christie Estimated Permeability: 5 to 50 mm/day Outcrop: None

Landscape position: Upper slope
 Microrelief: No microrelief
 Erosion: Partly stabilised Wind
 Vegetation: Pearl bluebush regrowing, corkscrew grass, medic. Belah nearby

DEPTH (centimetres)	Horizon	GRAPHIC LOG	PROFILE DESCRIPTION	Field pH	Moisture	Efferves- cence	Approximate Concretions	Field ECe (dS/m)	SAMPLE
	A1		Red loamy sand with weak grade of subangular blocky structure. Soil is not dispersive, partially slakes	7.5	Dry	Slight			
	A3		Red loamy sand with weak grade of subangular blocky structure. Soil is not dispersive, completely slakes	8	Dry	High		1	
50	B1		Red loam, fine sandy with weak grade of polyhedral structure. Soil is not dispersive, completely slakes	8	Dry	Very high	10% Carb		
	B2		Red loam, fine sandy with weak grade of polyhedral structure. Soil is not dispersive, completely slakes	8.5	Dry	Very high	10% Carb	11.1	
100									
150			COMMENTS: Surface 80% loose, 20% crust. 2% Ironstone in depth to 140 cm layer. Ironstone nodules most likely relict.

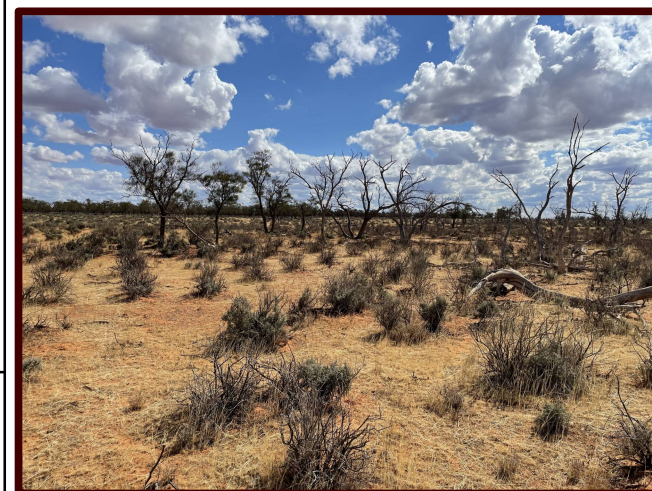
TEST HOLE SC2021

Date Excavated: 9/4/22 Australian Soil Class: Calcic Calcarosol Geology: Aeolian sand plain
 Logged by: PJH Datum: WGS 84 Annual Crop Rootzone (cm): 70 Landuse: Rangeland Grazing
 Easting: 531509 Northing: 6281231 Plant Available Water (mm): 70 Surface condition: Loose
 Surface Elevation(m): 55.0 Drainage: Poorly drained Surface gravel: None
 Equipment: Christie Estimated Permeability: 5 to 50 mm/day Outcrop: None

Landscape position: Upper slope
 Microrelief: No microrelief
 Erosion: Partly stabilised Wind
 Vegetation: Corkscrew grass, medic, few pearl bluebush regrowing

DEPTH (centimetres)	Horizon	GRAPHIC LOG	PROFILE DESCRIPTION	Field pH	Moisture	Efferves- cence	Approximate Concretions	Field ECe (dS/m)	SAMPLE
	A11		Red loamy sand with weak grade of subangular blocky structure. Soil is not dispersive, completely slakes	8	Dry	High			
	A12		Red loamy sand with weak grade of subangular blocky structure. Soil is not dispersive, completely slakes	8.5	Dry	High		2.8	
50	B1		Red silt loam with weak grade of polyhedral structure. Soil is not dispersive, partially slakes	9	Dry	Moderate	10% Carb		
100	B2k		Red fine sandy clay loam with weak grade of polyhedral structure. Soil is slightly dispersive, completely slakes	9	Dry	Very high	40% Carb	8.3	
150			COMMENTS: Surface 80% loose, 20% surface crust. Bottom of hole at 140

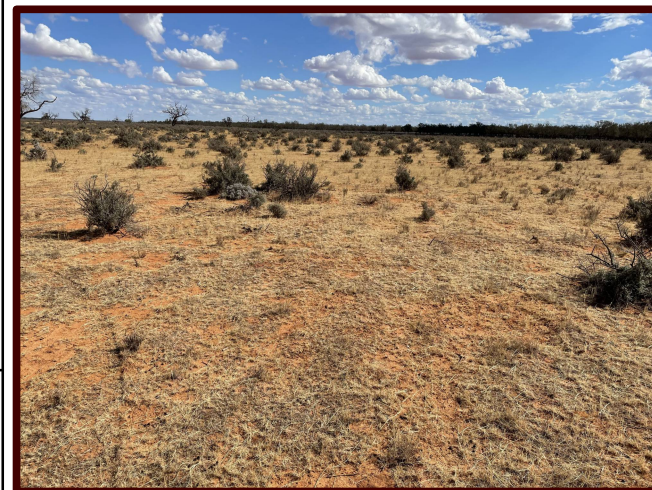
TEST HOLE SC2022

Date Excavated: 9/4/22 Australian Soil Class: Calcic Calcarosol Geology: Aeolian sand plain
Logged by: PJH Datum: WGS 84 Annual Crop Rootzone (cm): 50 Landuse: Rangeland Grazing
Easting: 531012 Northing: 6281255 Plant Available Water (mm): 49 Surface condition: Surface Flake
Surface Elevation(m): 55.6 Drainage: Well drained Surface gravel: None
Equipment: Christie Estimated Permeability: 5 to 50 mm/day Outcrop: None

DEPTH (centimetres)	Horizon	GRAPHIC LOG	PROFILE DESCRIPTION	Field pH	Moisture	Efferves- cence	Approximate Concretions	Field ECe (dS/m)	SAMPLE
	A11		Red loamy sand with weak grade of subangular blocky structure. Soil is not dispersive, partially slakes	8	Dry	Very high			
	A12		Red loamy sand with weak grade of subangular blocky structure. Soil is not dispersive, completely slakes	8	Dry	Very high		3.8	
50	B21		Red fine sandy clay loam with moderate grade of polyhedral structure. Soil is not dispersive, completely slakes	9	Dry	Very high	10% Carb		
100	B22		Red fine sandy clay loam with strong grade of polyhedral structure. Soil is not dispersive, completely slakes	9	Dry	Moderate	10% Carb	14.5	
150			COMMENTS: Surface 5% cryptogam crust, 50% surface flake, 45% loose. Bottom of hole at 130

Landscape position: Flat
Microrelief: No microrelief
Erosion: Partly stabilised Wind
Vegetation: Belah/Pearl bluebush/corkscrew grass

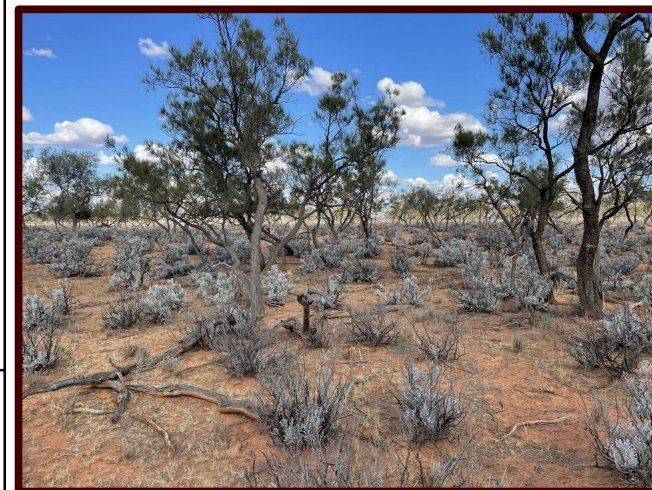
TEST HOLE SC2023

Date Excavated: 10/4/22 Australian Soil Class: Red Chromosol Geology: Blanchetown Clay
 Logged by: PJH Datum: WGS 84 Annual Crop Rootzone (cm): 40 Landuse: Rangeland Grazing
 Easting: 531211 Northing: 6280413 Plant Available Water (mm): 65 Surface condition: Surface Crust
 Surface Elevation(m): 33.7 Drainage: Well drained Surface gravel: None
 Equipment: Christie Estimated Permeability: 5 to 50 mm/day Outcrop: None

Landscape position: Lower Slope
 Microrelief: No microrelief
 Erosion: Active Gully
 Vegetation: Scattered pearl bluebush, saltbush, medic, corkscrew grass

DEPTH (centimetres)	Horizon	GRAPHIC LOG	PROFILE DESCRIPTION	Field pH	Moisture	Efferves- cence	Approximate Concretions	Field ECe (dS/m)	SAMPLE
	A11		Red loamy sand with weak grade of subangular blocky structure. Soil is not dispersive, partially slakes	7.5	Dry	Nil			
	A3		Red sandy loam with strong grade of angular blocky structure. Soil is not dispersive, doesn't slake	8	Trace	Nil		24.5	
50									
	B2t		Red sandy clay with strong grade of polyhedral structure. Soil is not dispersive, doesn't slake	8.5	Trace	Very high	5% Gyp	25.2	
100									
150			COMMENTS: Surface 80% surface crust, 20% cryptogam crust. Bottom of hole at 140

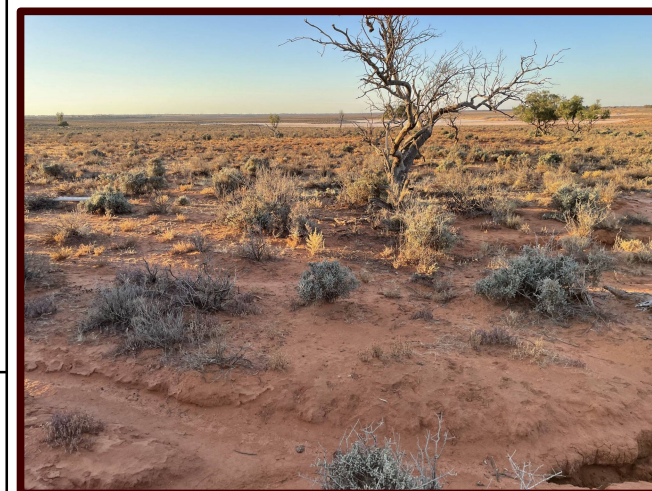
TEST HOLE SC2024

Date Excavated: 10/4/22 Australian Soil Class: Red Chromosol Geology: Aeolian sand plain
Logged by: PJH Datum: WGS 84 Annual Crop Rootzone (cm): 80 Landuse: Rangeland Grazing
Easting: 529890 Northing: 6281614 Plant Available Water (mm): 84 Surface condition: Cryptogram crust
Surface Elevation(m): 45.7 Drainage: Moderately well drained Surface gravel: None
Equipment: Christie Estimated Permeability: 5 to 50 mm/day Outcrop: None

Landscape position: Flat
Microrelief: No microrelief
Erosion: Stabilised
Vegetation: Belah pearl bluebush, corkscrew grass, medic

DEPTH (centimetres)	Horizon	GRAPHIC LOG	PROFILE DESCRIPTION	Field pH	Moisture	Efferves- cence	Approximate Concretions	Field ECe (dS/m)	SAMPLE
	A1		Red loamy sand with weak grade of subangular blocky structure. Soil is slightly dispersive, completely slakes	8	Dry	Very high			
	A3		Red loam, fine sandy with weak grade of subangular blocky structure. Soil is not dispersive, completely slakes	9	Dry	High		16.8	
50	B22		Red fine sandy clay loam with moderate grade of polyhedral structure. Soil is slightly dispersive, completely slakes	9	Dry	High	5% Carb		
100	B23		Red fine sandy clay loam with moderate grade of polyhedral structure. Soil is not dispersive, completely slakes	9	Dry	Moderate	10% Carb	24	
150			COMMENTS: Soil built up around base of bluebush. 2% Ironstone in B23 Layer. Bottom of hole at 140

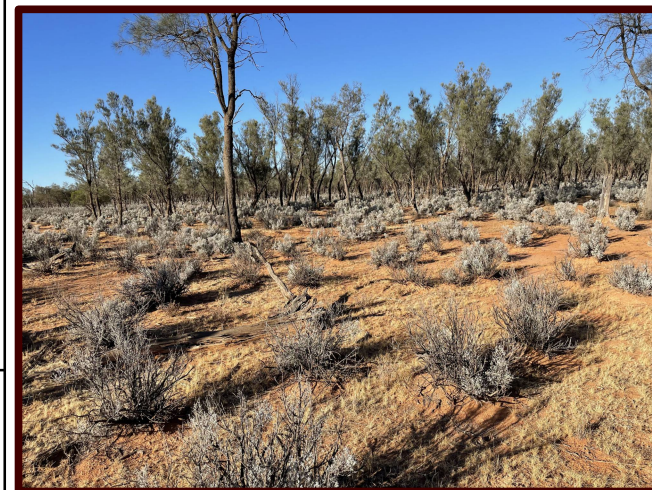
TEST HOLE SC2025

Date Excavated: 10/4/22 Australian Soil Class: Hypercalcic Calcarosol Geology: Blanchetown Clay
Logged by: PJH Datum: WGS 84 Annual Crop Rootzone (cm): 40 Landuse: Rangeland Grazing
Easting: 529049 Northing: 6279273 Plant Available Water (mm): 34 Surface condition: Cryptogram crust
Surface Elevation(m): 30.2 Drainage: Moderately well drained Surface gravel: None
Equipment: Christie Estimated Permeability: 5 to 50 mm/day Outcrop: None

Landscape position: Lower Slope
Microrelief: No microrelief
Erosion: Partly stabilised Gully
Vegetation: Saltbush, corkscrew grass, medic

DEPTH (centimetres)	Horizon	GRAPHIC LOG	PROFILE DESCRIPTION	Field pH	Moisture	Efferves- cence	Approximate Concretions	Field ECe (dS/m)	SAMPLE
	A1		Red loamy sand with weak grade of subangular blocky structure. Soil is not dispersive, completely slakes	7.5	Dry	Nil			
50	A3		Red loam, fine sandy with moderate grade of subangular blocky structure. Soil is not dispersive, partially slakes	7.5	Dry	Nil		24	
	B22		Red sandy loam with moderate grade of polyhedral structure. Soil is not dispersive, completely slakes	8	Trace	Moderate	10% Carb		
100	B23y		Red sandy loam with moderate grade of polyhedral structure. Soil is not dispersive, completely slakes	8.5	Moist	High	20% Gyp	49.5	
150			COMMENTS: Erosion type - Gully/Rill. Bottom of hole at 140

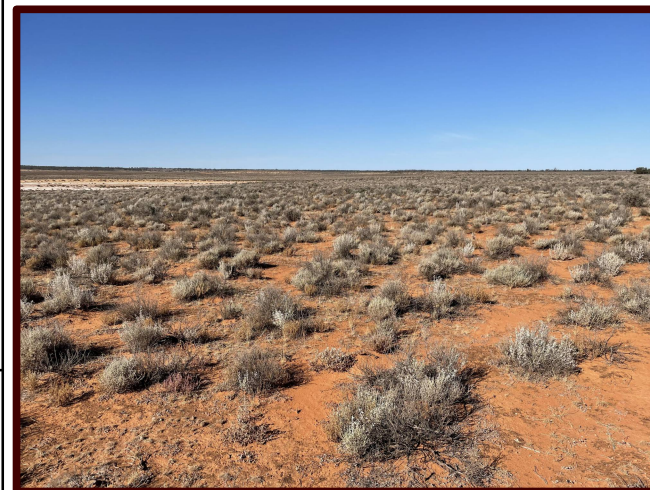
TEST HOLE SC2026

Date Excavated: 10/4/22 Australian Soil Class: Hypersalic Hydrosol Geology: Yamba Formation
 Logged by: PJH Datum: WGS 84 Annual Crop Rootzone (cm): 15 Landuse: Rangeland Grazing
 Easting: 529784 Northing: 6278038 Plant Available Water (mm): 21 Surface condition: Loose
 Surface Elevation(m): 26.3 Drainage: Poorly drained Surface gravel: None
 Equipment: Christie Estimated Permeability: < 5 mm/day Outcrop: None

DEPTH (centimetres)	Horizon	GRAPHIC LOG	PROFILE DESCRIPTION	Field pH	Moisture	Efferves- cence	Approximate Concretions	Field ECe (dS/m)	SAMPLE
	A		Brown light sandy clay loam with weak grade of polyhedral structure. Soil is not dispersive, doesn't slake	8.5	Trace	Slight			
	B1		Brown sandy clay loam with strong grade of polyhedral structure. Soil is not dispersive, partially slakes	8.5	Trace	Nil		64.5	
50	B22y		Brown sandy clay with strong grade of polyhedral structure. Soil is not dispersive, completely slakes	7	Moist	Nil	50% Gyp		
	B23y		Brown sandy clay loam with strong grade of polyhedral structure. Soil is not dispersive, completely slakes	7	Moist	Nil	40% Gyp	68	
100			COMMENTS: Saturated at 100, soil below 100 grey SiC. Bottom of hole at 100						
150

Landscape position: Closed depression
 Microrelief: No microrelief
 Erosion: Stabilised
 Vegetation: Saltbush

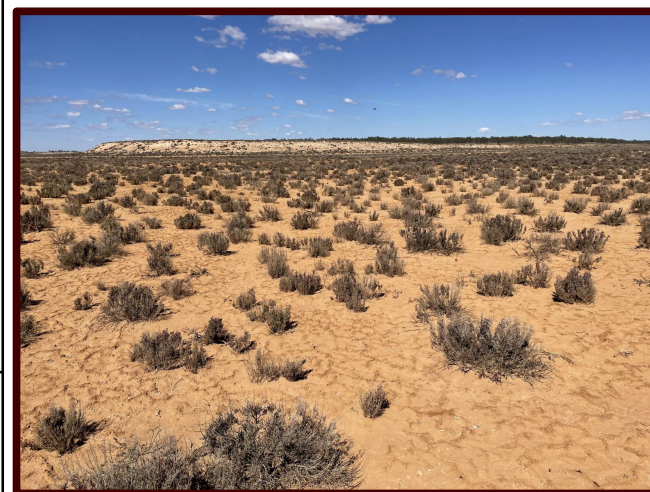
TEST HOLE SC2027

Date Excavated: 10/4/22 Australian Soil Class: Hypersalic Hydrosol Geology: Yamba Formation
Logged by: PJH Datum: WGS 84 Annual Crop Rootzone (cm): 10 Landuse: Rangeland Grazing
Easting: 529308 Northing: 6278051 Plant Available Water (mm): 9 Surface condition: Surface Flake
Surface Elevation(m): 26.3 Drainage: Poorly drained Surface gravel: 2% fine gravel carbonate
Equipment: Christie Estimated Permeability: 5 to 50 mm/day Outcrop: None

DEPTH (centimetres)	Horizon	GRAPHIC LOG	PROFILE DESCRIPTION	Field pH	Moisture	Efferves- cence	Approximate Concretions	Field ECe (dS/m)	SAMPLE
	A

Grey fine sandy clay loam with strong grade of polyhedral structure. Soil is not dispersive, completely slakes	8.5	Wet	Nil	50% Gyp	54.5	
100			COMMENTS: Salt efflorescence on surface. B22 moisture S - Saturated. Bottom of hole at 100						
150

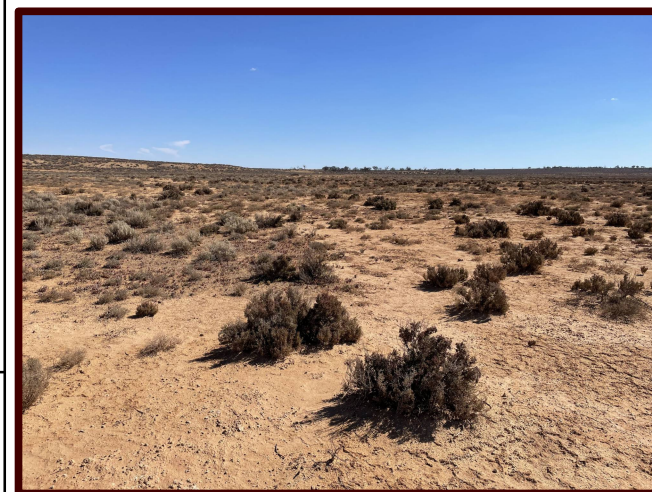
TEST HOLE SC2028

Date Excavated: 10/4/22 Australian Soil Class: Hypersalic Hydrosol Geology: Yamba Formation
 Logged by: PJH Datum: WGS 84 Annual Crop Rootzone (cm): 30 Landuse: Rangeland Grazing
 Easting: 529511 Northing: 6278652 Plant Available Water (mm): 35 Surface condition: Surface Flake
 Surface Elevation(m): 26.4 Drainage: Poorly drained Surface gravel: None
 Equipment: Christie Estimated Permeability: 5 to 50 mm/day Outcrop: None

DEPTH (centimetres)	Horizon	GRAPHIC LOG	PROFILE DESCRIPTION	Field pH	Moisture	Efferves- cence	Approximate Concretions	Field ECe (dS/m)	SAMPLE
	A

Brown sandy clay loam with moderate grade of polyhedral structure. With 10%O mottle. Soil is not dispersive, completely slakes	8.5	Wet	Nil	50% Gyp	64	
150			COMMENTS: Top soil structure is good. Small rise of wind blown sand in closed depression. Landform element - small rise. Bottom of hole at 120

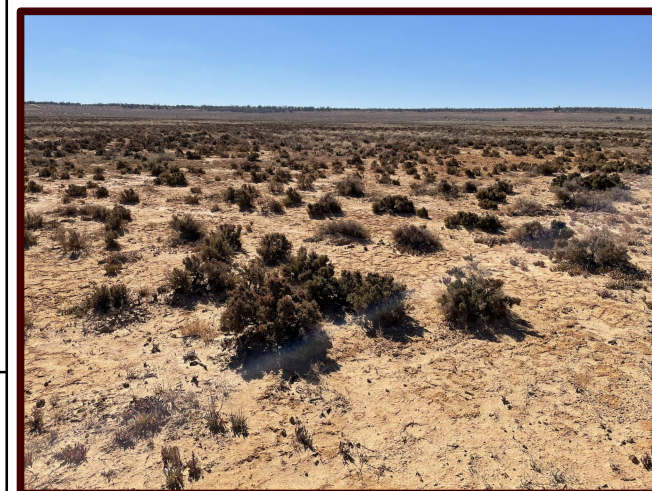
TEST HOLE SC2029

Date Excavated: 10/4/22 Australian Soil Class: Hypersalic Hydrosol Geology: Aeolian lunette with kopi
 Logged by: PJH Datum: WGS 84 Annual Crop Rootzone (cm): 40 Landuse: Rangeland Grazing
 Easting: 529658 Northing: 6278830 Plant Available Water (mm): 31 Surface condition: Surface Flake
 Surface Elevation(m): 26.4 Drainage: Poorly drained Surface gravel: None
 Equipment: Christie Estimated Permeability: 5 to 50 mm/day Outcrop: None

Landscape position: Closed depression
 Microrelief: No microrelief
 Erosion: Stabilised
 Vegetation: Pigface, saltbush, samphire

DEPTH (centimetres)	Horizon	GRAPHIC LOG	PROFILE DESCRIPTION	Field pH	Moisture	Efferves- cence	Approximate Concretions	Field ECe (dS/m)	SAMPLE
	A1		Red silt loam with weak grade of subangular blocky structure. Soil is not dispersive, doesn't slake	5.5	Dry	Nil			
	A3y		Brown sandy loam with moderate grade of polyhedral structure. Soil is not dispersive, completely slakes	8.5	Trace	Nil	70% Gyp	48	
50	B2y		Brown light clay with moderate grade of polyhedral structure. Soil is not dispersive, completely slakes	8.5	Wet	Nil	40% Gyp		
100	B3y		Grey sandy clay loam with moderate grade of polyhedral structure. With 20%R mottle. Soil is not dispersive, partially slakes	8.5	Wet	Nil	30% Gyp	90	
150			COMMENTS: Bottom of hole at 140
