Land and Soil Capability Assessment

prepared by
Sustainable Soils Management Pty Ltd

Copi Mineral Sands Project

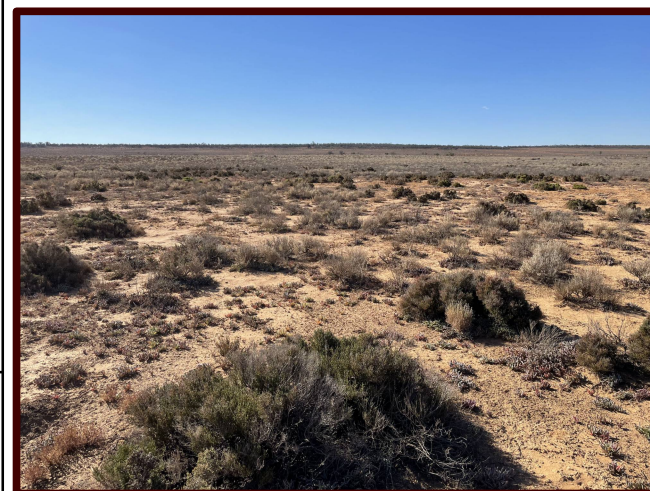
TEST HOLE SC2030

Date Excavated: 10/4/22 Australian Soil Class: Red Arenosol Geology: Yamba Formation
 Logged by: PJH Datum: WGS 84 Annual Crop Rootzone (cm): 100 Landuse: Rangeland Grazing
 Easting: 533241 Northing: 6280684 Plant Available Water (mm): 86 Surface condition: Cryptogram crust
 Surface Elevation(m): 32.9 Drainage: Rapidly drained Surface gravel: None
 Equipment: Christie Estimated Permeability: > 500 mm/day Outcrop: None

Landscape position: Crest
 Microrelief: No microrelief
 Erosion: Active Wind
 Vegetation: Cannonball, corkscrew grass

DEPTH (centimetres)	Horizon	GRAPHIC LOG	PROFILE DESCRIPTION	Field pH	Moisture	Efferves- cence	Approximate Concretions	Field ECe (dS/m)	SAMPLE
	A1		Red loamy sand. Soil is not dispersive, completely slakes	7	Dry	Nil			
50	A3		Red loamy sand. Soil is not dispersive, completely slakes	8	Dry	Nil		4.6	
	B2		Red loamy sand. Soil is not dispersive, completely slakes	8.5	Dry	Very high			
100	B3		Red loamy sand. Soil is not dispersive, completely slakes	8.5	Dry	Very high		3.5	
150			COMMENTS: Moving sand dune. Bottom of hole at 140

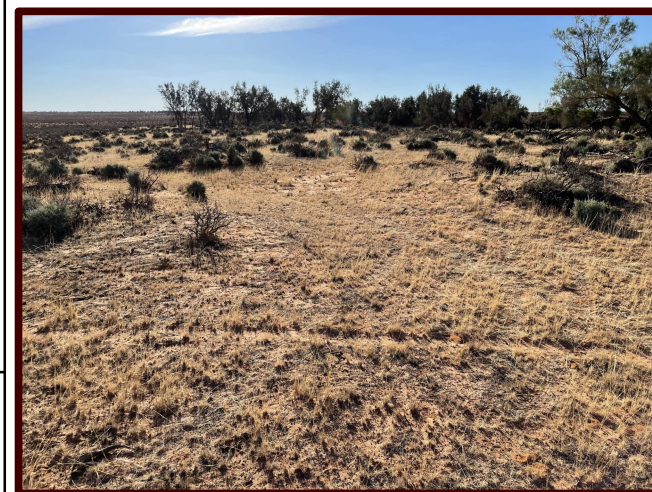
TEST HOLE SC2031

Date Excavated: 11/4/22 Australian Soil Class: Red Kandosol Geology: Aeolian lunette with kopi
 Logged by: PJH Datum: WGS 84 Annual Crop Rootzone (cm): 100 Landuse: Rangeland Grazing
 Easting: 530646 Northing: 6279768 Plant Available Water (mm): 86 Surface condition: Cryptogram crust
 Surface Elevation(m): 32.5 Drainage: Rapidly drained Surface gravel: None
 Equipment: Christie Estimated Permeability: > 500 mm/day Outcrop: None

DEPTH (centimetres)	Horizon	GRAPHIC LOG	PROFILE DESCRIPTION	Field pH	Moisture	Efferves- cence	Approximate Concretions	Field ECe (dS/m)	SAMPLE
	A1		Red loamy sand with weak grade of subangular blocky structure. Soil is not dispersive, completely slakes	8.5	Dry	Nil			
50	A3		Red loamy sand with weak grade of subangular blocky structure. Soil is not dispersive, completely slakes	8.5	Dry	Nil		0.8	
	B1		Brown loam, fine sandy with weak grade of subangular blocky structure. Soil is not dispersive, partially slakes	8.5	Dry	Moderate			
100	B2		Red loam, fine sandy with weak grade of subangular blocky structure. Soil is not dispersive, doesn't slake	8.5	Dry	Very high	2% Carb	2.2	
150			COMMENTS: Bottom of hole at 140

Landscape position: Upper slope
 Microrelief: No microrelief
 Erosion: Partly stabilised Rill
 Vegetation: Pearl bluebush, medic, corkscrew grass, belah

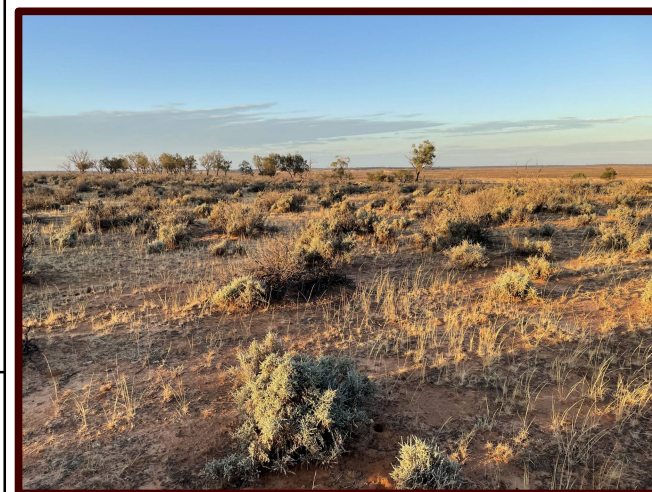
TEST HOLE SC2032

Date Excavated: 11/4/22 Australian Soil Class: Hypersalic Hydrosol Geology: Yamba Formation
 Logged by: PJH Datum: WGS 84 Annual Crop Rootzone (cm): 25 Landuse: Rangeland Grazing
 Easting: 529927 Northing: 6279149 Plant Available Water (mm): 22 Surface condition: Surface Crust
 Surface Elevation(m): 26.7 Drainage: Poorly drained Surface gravel: None
 Equipment: Christie Estimated Permeability: 5 to 50 mm/day Outcrop: None

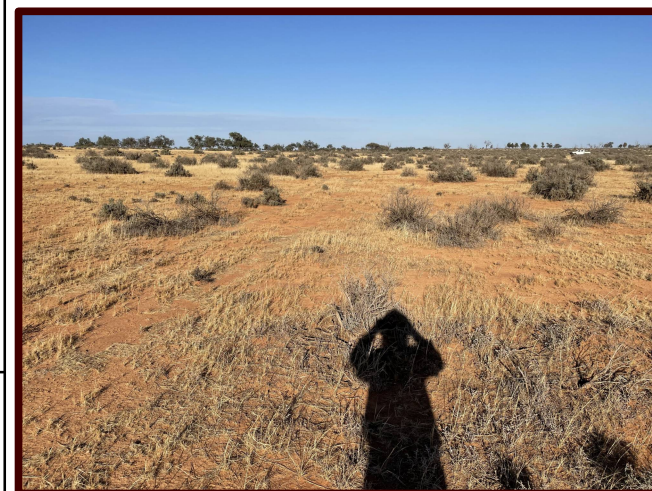
TEST HOLE SC2044

DEPTH (centimetres)	Horizon	GRAPHIC LOG	PROFILE DESCRIPTION	Field pH	Moisture	Efferves- cence	Approximate Concretions	Field ECe (dS/m)	SAMPLE
	A1		Red loam, fine sandy with weak grade of subangular blocky structure and ped size of cm breaking to cm. Soil is not dispersive, partially slakes	8.5	Dry	Very high			
50	A3		Red sandy loam with moderate grade of angular blocky structure. Soil is not dispersive, partially slakes	8.5	Dry	Very high	5% Carb	6.7	
	B1k		Red sandy clay loam with moderate grade of polyhedral structure. Soil is not dispersive, completely slakes	8.5	Dry	Very high	20% Carb		
100	B2tk		Red light clay with strong grade of polyhedral structure. Soil is not dispersive, completely slakes	8.5	Dry	Very high	30% Carb	7.7	
150			COMMENTS: Bottom of hole at 140

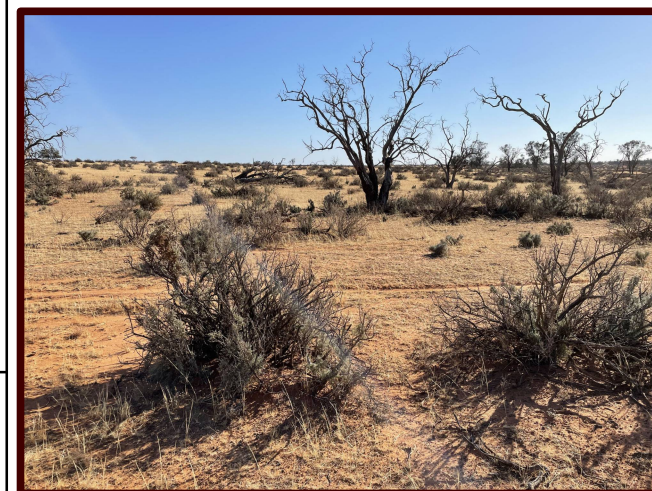
TEST HOLE SC2045

Red silty clay loam with weak grade of polyhedral structure. Soil is strongly dispersive, completely slakes	8.5	Dry	Very high	50% Carb	4	
150			COMMENTS: Lee of dune. Erosion starts with sheep pads. Dead belah nearby. Bottom of hole at 140

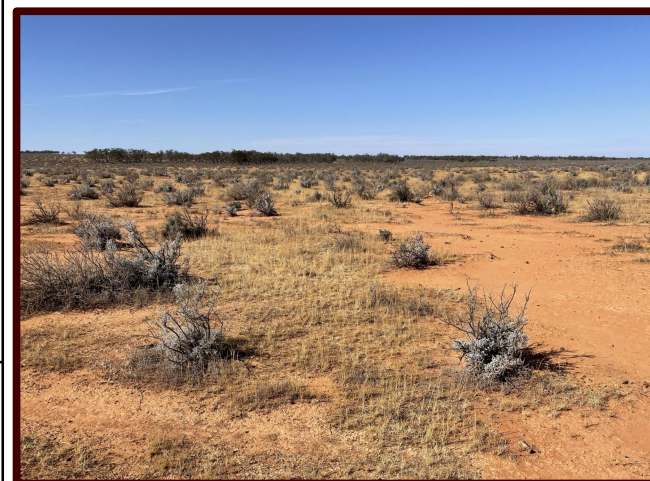
TEST HOLE SC2046

DEPTH (centimetres)	Horizon	GRAPHIC LOG	PROFILE DESCRIPTION	Field pH	Moisture	Efferves- cence	Approximate Concretions	Field ECe (dS/m)	SAMPLE
	A		Red sandy clay loam with strong grade of polyhedral structure. Soil is not dispersive, completely slakes	8.5	Dry	Slight	2% Carb		
	B22		Red silty clay loam with moderate grade of polyhedral structure. Soil is not dispersive, completely slakes	8.5	Dry	Moderate	10% Carb	23	
50	B23k		Red silty clay loam with moderate grade of polyhedral structure. Soil is not dispersive, completely slakes	8.5	Dry	Very high	30% Carb		
100	B3y		Red silty clay loam with moderate grade of polyhedral structure. Soil is not dispersive, completely slakes	8.5	Trace	Moderate	50% Gyp	43.5	
150			COMMENTS: Looks like topsoil is subsoil exposed by erosion. Bottom of hole at 140

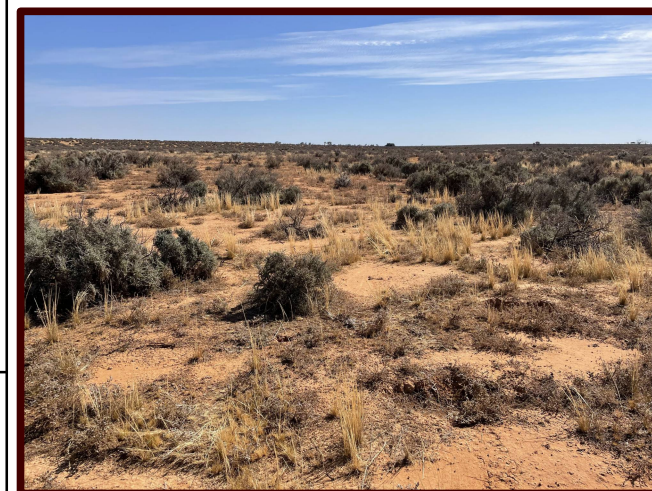
TEST HOLE SC2047

Red light clay with strong grade of polyhedral structure. Soil is not dispersive, completely slakes	8.5	Dry	Moderate	60% Gyp	9.5	
150			COMMENTS: Surface condition - 60% Cryptogram crust, 40% hardset. Some shrinkage cracks nearby.

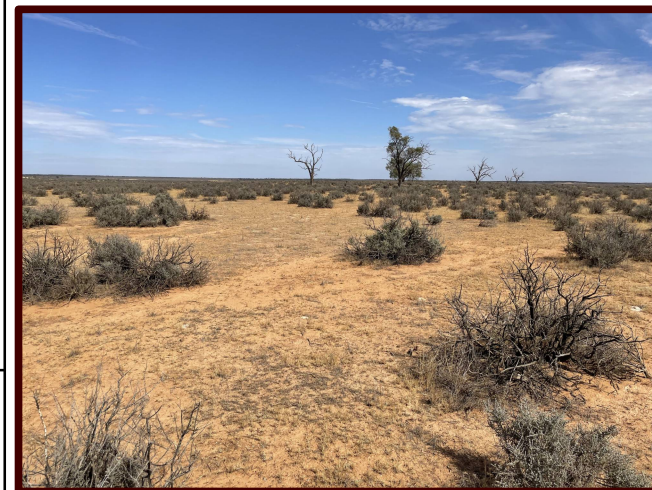
TEST HOLE SC2048

DEPTH (centimetres)	Horizon	GRAPHIC LOG	PROFILE DESCRIPTION	Field pH	Moisture	Efferves- cence	Approximate Concretions	Field ECe (dS/m)	SAMPLE
	A		Red sandy loam with massive grade of structure and ped size of 0.5. Soil is not dispersive, doesn't slake, has a poor to moderate SOILpak score and has an average number of roots present.	8.5	Dry	Moderate			
	B21y		Yellow silt loam with weak grade of subangular blocky structure. Soil is not dispersive, partially slakes	7.5	Dry	Nil	90% Gyp	22.5	
50									
	B22y		Yellow silt loam with weak grade of polyhedral structure. Soil is not dispersive, completely slakes	7.5	Dry	Nil	90% Gyp		
100									
	B23y		Yellow loamy sand with weak grade of polyhedral structure. Soil is not dispersive, completely slakes	8.5	Trace	Nil	80% Gyp	19.8	
150			COMMENTS: Surface condition - 70% hardset, 30% cryptogram crust. Copi Hill' Bottom of hole at 140

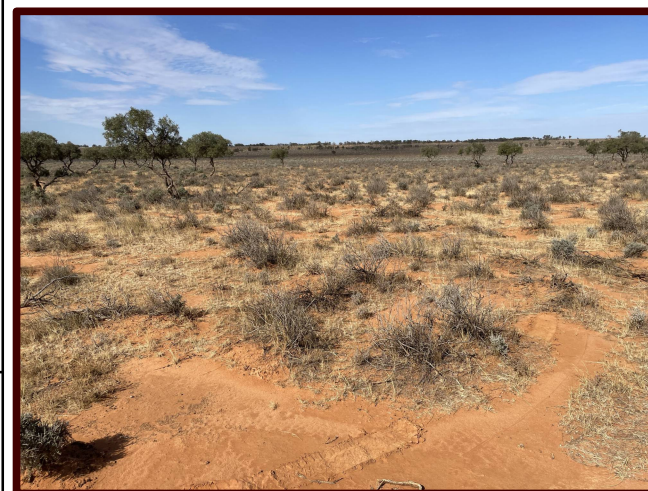
TEST HOLE SC2051

DEPTH (centimetres)	Horizon	GRAPHIC LOG	PROFILE DESCRIPTION	Field pH	Moisture	Efferves- cence	Approximate Concretions	Field ECe (dS/m)	SAMPLE
	A1		Red sandy loam with weak grade of subangular blocky structure. Soil is not dispersive, completely slakes	8.5	Dry	High			
50	A3		Red sandy loam with weak grade of polyhedral structure. Soil is not dispersive, completely slakes	8.5	Dry	High		27.5	
	B1k		Yellow silty clay loam with moderate grade of polyhedral structure. Soil is not dispersive, completely slakes	8.5	Trace	High	20% Carb		
100	B2k		Red silty clay loam with moderate grade of polyhedral structure. Soil is not dispersive, completely slakes	9	Trace	High	30% Carb	23	
150			COMMENTS: Surface condition - 50% loose, 40% hardset, 10% cryptogram crust. Carbonate appears to be sheet.

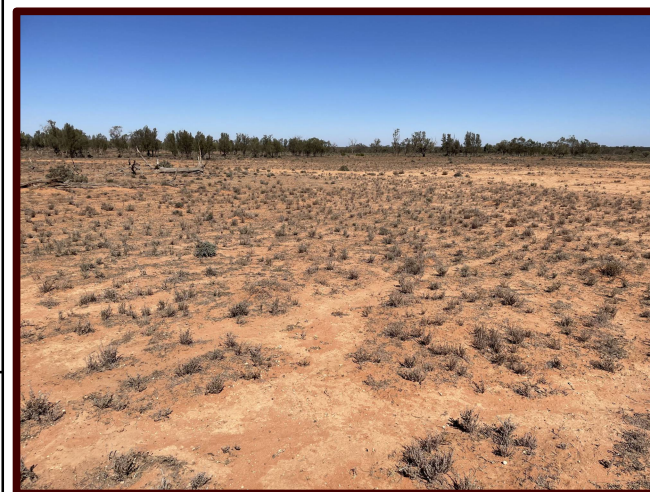
TEST HOLE SC2058

DEPTH (centimetres)	Horizon	GRAPHIC LOG	PROFILE DESCRIPTION	Field pH	Moisture	Efferves- cence	Approximate Concretions	Field ECe (dS/m)	SAMPLE
	A11		Red sandy loam with weak grade of subangular blocky structure. Soil is not dispersive, partially slakes	8	Dry	Very high			
	A12		Red sandy loam with weak grade of subangular blocky structure. Soil is not dispersive, completely slakes	8.5	Dry	Very high	5% Carb	4.4	
50	B1k		Red sandy clay loam with moderate grade of polyhedral structure. Soil is slightly dispersive, completely slakes	8.5	Dry	Very high	30% Carb		
100	B2k		Red light clay with moderate grade of polyhedral structure. Soil is not dispersive, completely slakes	8.5	Dry	High	20% Carb	10.5	
150			COMMENTS: Edge of Scald. Refusal @ 110 cm. Bottom of hole at 110

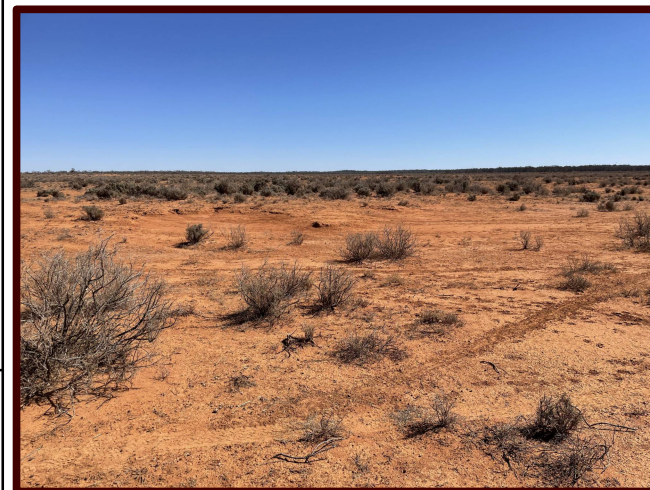
TEST HOLE SC2059

Grey medium heavy clay with strong grade of polyhedral structure and ped size of cm breaking to cm. Soil is not dispersive, completely slakes	7	Trace	Nil	20% Gyp	49	
150			COMMENTS: Gypsum in 2B in layers 2 cm thick interbedded with 10 cm grey soil. Slickensides in 2B. Surface condition - Friable.

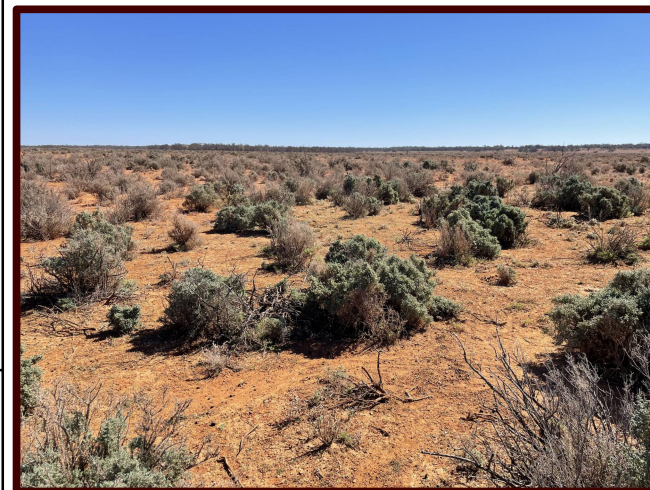
TEST HOLE SC2060

Red light medium clay with strong grade of polyhedral structure. Soil is not dispersive, completely slakes	9	Dry	Moderate	10% Gyp	18.6	
150			COMMENTS: Edge of closed depression on lower slope. Seedlings of medic and some broadleaves. Roots in B22 growing in fissures between rough faced peds. Bottom of hole at 140

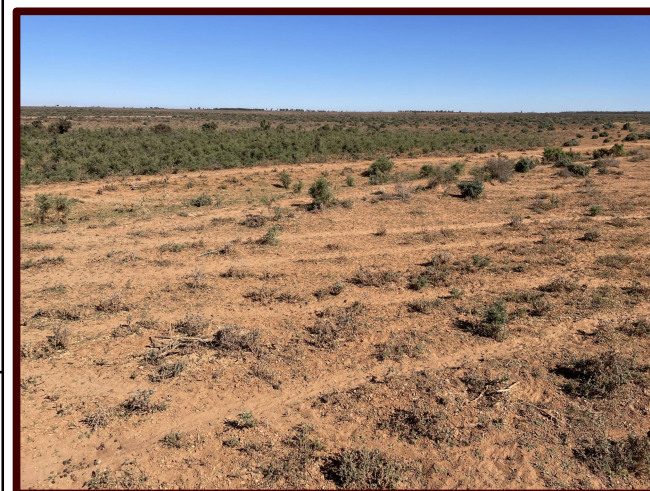
TEST HOLE SC2061

Brown light clay with moderate grade of polyhedral structure and ped size of cm breaking to cm. Soil is moderately dispersive, completely slakes	9	Dry	Very high	20% Carb	1.1	
150			COMMENTS: May contain silt from diversion of runoff to dam. Really a buried Calcarosol.

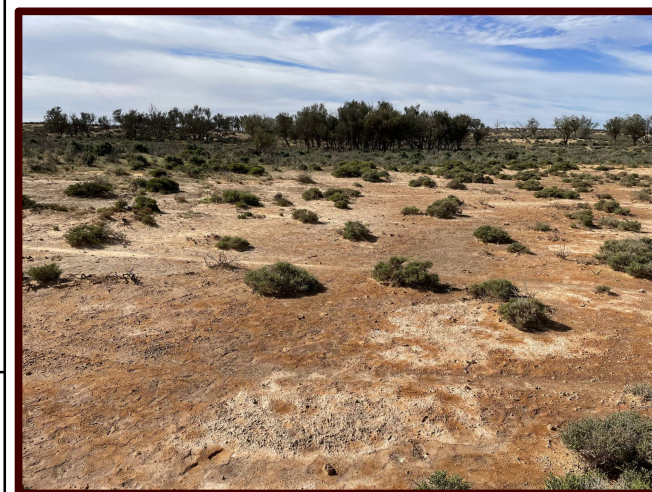
TEST HOLE SC2067

Red light clay with weak grade of polyhedral structure. Soil is not dispersive, completely slakes	8	Moist	Slight	30% Gyp	37.5	
150			COMMENTS: Discharge area. A horizon is Copi. Surface condition - salt efflorescence

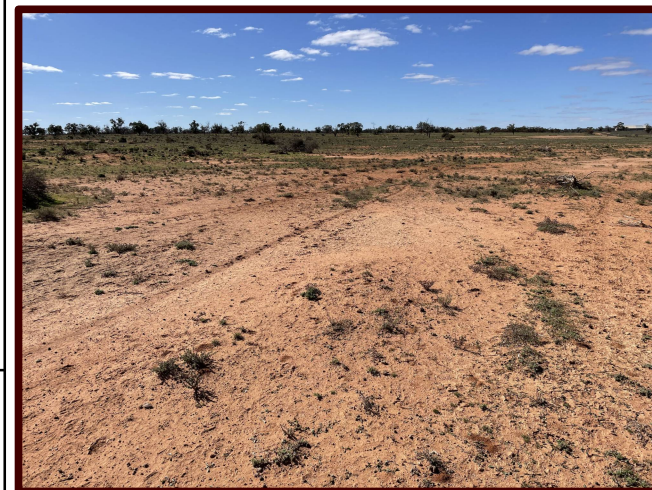
TEST HOLE SC2072

DEPTH (centimetres)	Horizon	GRAPHIC LOG	PROFILE DESCRIPTION	Field pH	Moisture	Efferves- cence	Approximate Concretions	Field ECe (dS/m)	SAMPLE
	A		Red light clay with strong grade of prismatic structure. Soil is not dispersive, completely slakes	8.5	Trace	Very high	2% Carb		
50	B1		Brown light medium clay with strong grade of prismatic structure. Soil is not dispersive, completely slakes	8	Trace	Very high		23.1	
	B22		Grey light medium clay with strong grade of prismatic structure. With 20% R mottle. Soil is not dispersive, completely slakes	8	Trace	Very high	2% Carb		
100	B23		Grey light medium clay with strong grade of prismatic structure. With 5% R mottle. Soil is not dispersive, completely slakes	8	Trace	Nil	2% Carb	21.7	
150			COMMENTS: Slickensides in B horizon. Some mangans in B1. Erosion - Water Bottom of hole at 140

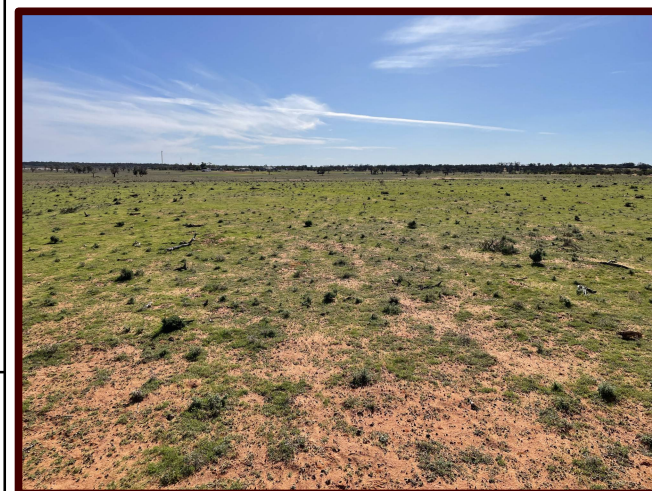
TEST HOLE SC2074

DEPTH (centimetres)	Horizon	GRAPHIC LOG	PROFILE DESCRIPTION	Field pH	Moisture	Efferves- cence	Approximate Concretions	Field ECe (dS/m)	SAMPLE
	A1		Red loamy sand with weak grade of subangular blocky structure. Soil is not dispersive, completely slakes	8	Moist	High			
50	A3		Red loamy sand with weak grade of subangular blocky structure. Soil is slightly dispersive, completely slakes	8	Moist	High		1.6	
100	B		Red loamy sand with moderate grade of polyhedral structure. Soil is not dispersive, partially slakes	9	Dry	Very high	5% Carb	4.6	
150			COMMENTS: Looks like sand is moving. Belah 20 m away Bottom of hole at 120

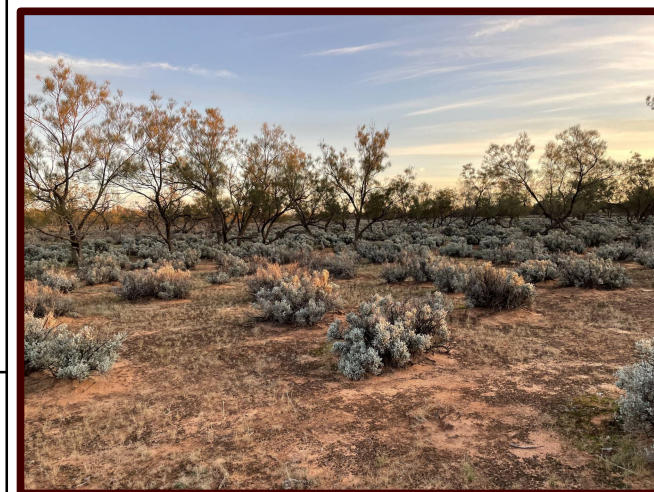
TEST HOLE SC2077

Date Excavated: 10/5/22 Australian Soil Class: Hypergypsic Calcarosol Geology: Yamba Formation
 Logged by: PJH Datum: WGS 84 Annual Crop Rootzone (cm): 30 Landuse: Rangeland Grazing
 Easting: 530080 Northing: 6279014 Plant Available Water (mm): 35 Surface condition: Firm
 Surface Elevation(m): 26.6 Drainage: Imperfectly drained Surface gravel: None
 Equipment: Christie corer Estimated Permeability: < 5 mm/day Outcrop: None

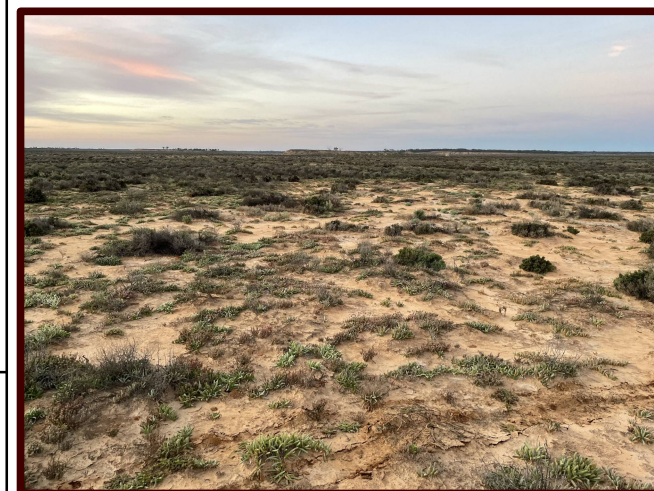
TEST HOLE SC2078

Date Excavated: 10/5/22 Australian Soil Class: Red Kandosol Geology: Aeolian lunette with kopi
Logged by: PJH Datum: WGS 84 Annual Crop Rootzone (cm): 120 Landuse: Rangeland Grazing
Easting: 529670 Northing: 6276293 Plant Available Water (mm): 127 Surface condition: Hardset
Surface Elevation(m): 31.0 Drainage: Well drained Surface gravel: None
Equipment: Christie corer Estimated Permeability: 50 to 500 mm/day Outcrop: None

DEPTH (centimetres)	Horizon	GRAPHIC LOG	PROFILE DESCRIPTION	Field pH	Moisture	Efferves- cence	Approximate Concretions	Field ECe (dS/m)	SAMPLE
	A11		Red sandy loam with weak grade of subangular blocky structure. Soil is not dispersive, completely slakes	8	Moist	Nil			
50	A12		Red sandy loam with weak grade of subangular blocky structure. Soil is not dispersive, completely slakes	7.5	Moist	High		2.4	
	A2		Red sandy loam with moderate grade of polyhedral structure. Soil is not dispersive, partially slakes	7.5	Moist	High			
100	By		Red sandy loam with moderate grade of polyhedral structure. Soil is not dispersive, completely slakes	7.5	Dry	Very high	50% Gyp	5.7	
150			COMMENTS: Gypsite north on lower level. Bottom of hole at 140

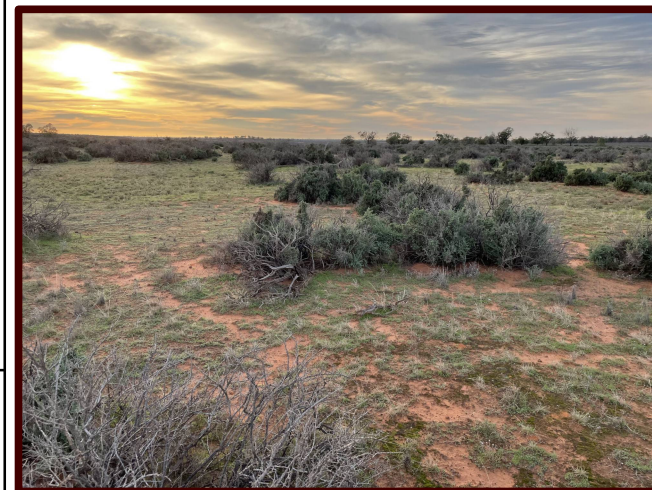
TEST HOLE SC2079

Date Excavated: 10/5/22 Australian Soil Class: Calcic Calcarosol Geology: Aeolian sand plain
Logged by: PJH Datum: WGS 84 Annual Crop Rootzone (cm): 70 Landuse: Rangeland Grazing
Easting: 530136 Northing: 6275837 Plant Available Water (mm): 95 Surface condition: Loose
Surface Elevation(m): 36.8 Drainage: Well drained Surface gravel: None
Equipment: Christie corer Estimated Permeability: 5 to 50 mm/day Outcrop: None

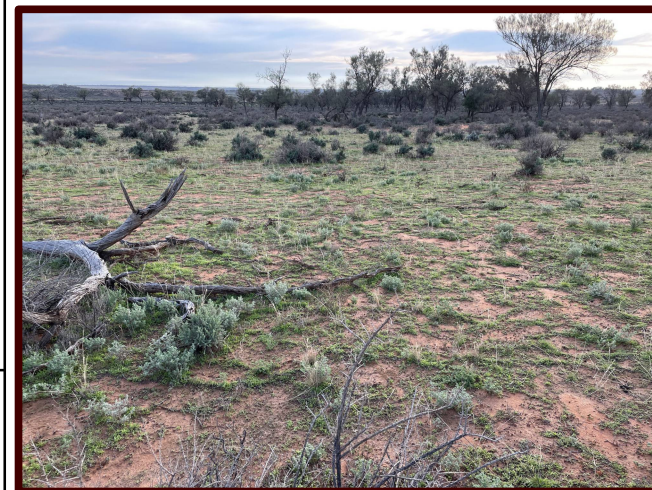
TEST HOLE SC2080

Date Excavated: 10/5/22 Australian Soil Class Supracalcic Calcarosol Geology: Woorinen Formation
Logged by: PJH Datum: WGS 84 Annual Crop Rootzone (cm): 80 Landuse: Rangeland Grazing
Easting: 539701 Northing: 6277015 Plant Available Water (mm): 76 Surface condition: Hardset
Surface Elevation(m): 58.0 Drainage: Moderately well drained Surface gravel: None
Equipment: Christie corer Estimated Permeability: 5 to 50 mm/day Outcrop: None

DEPTH (centimetres)	Horizon	GRAPHIC LOG	PROFILE DESCRIPTION	Field pH	Moisture	Efferves- cence	Approximate Concretions	Field ECe (dS/m)	SAMPLE
	A		Red loam, fine sandy with weak grade of subangular blocky structure. Soil is not dispersive, partially slakes	7.5	Moist	High			
50	B21k		Red sandy clay loam with strong grade of polyhedral structure. Soil is not dispersive, completely slakes	8	Moist	Very high	30% Carb		
	B22k		Red sandy clay loam with strong grade of polyhedral structure. Soil is slightly dispersive, completely slakes	8	Dry	Very high	20% Carb		
100	B23		Red sandy clay loam with strong grade of polyhedral structure. Soil is not dispersive, completely slakes	8	Dry	Very high	10% Carb		
150			COMMENTS: Rough surface. Scald moving? Bottom of hole at 140

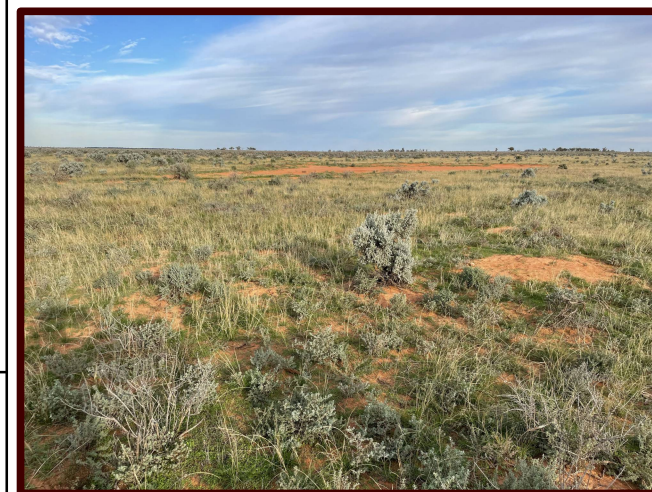
TEST HOLE SC2081

Date Excavated: 10/5/22 Australian Soil Class: Red Chromosol Geology: Aeolian sand plain
 Logged by: PJH Datum: WGS 84 Annual Crop Rootzone (cm): 80 Landuse: Rangeland Grazing
 Easting: 531488 Northing: 6281073 Plant Available Water (mm): 92 Surface condition: Firm
 Surface Elevation(m): 52.0 Drainage: Well drained Surface gravel: None
 Equipment: Christie corer Estimated Permeability: 5 to 50 mm/day Outcrop: None

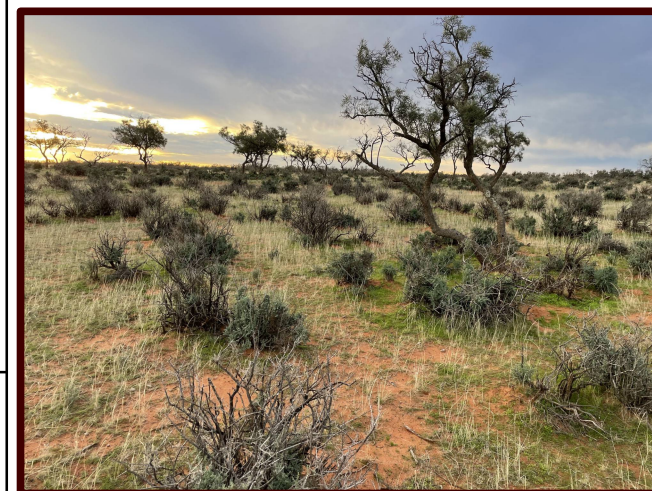
TEST HOLE SC2082

Date Excavated: 10/5/22 Australian Soil Class: Red Chromosol Geology: Aeolian sand plain
 Logged by: PJH Datum: WGS 84 Annual Crop Rootzone (cm): 60 Landuse: Rangeland Grazing
 Easting: 531838 Northing: 6281224 Plant Available Water (mm): 65 Surface condition: Firm
 Surface Elevation(m): 52.6 Drainage: Well drained Surface gravel: None
 Equipment: Christie corer Estimated Permeability: 5 to 50 mm/day Outcrop: None

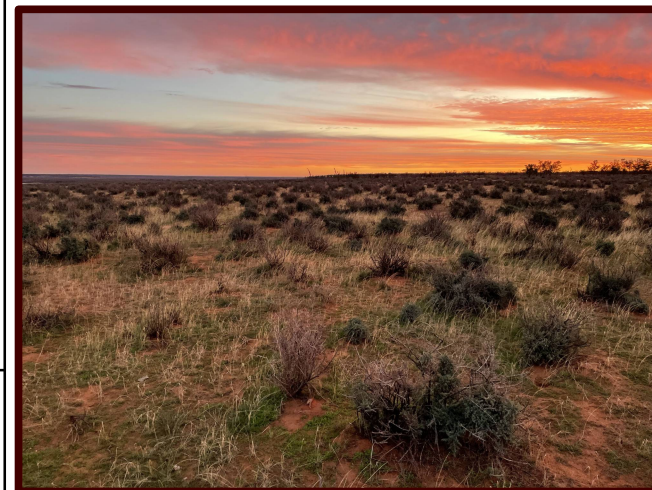
TEST HOLE SC2083

Date Excavated: 19/5/22 Australian Soil Class: Calcic Calcarosol Geology: Aeolian sand plain
 Logged by: PJH Datum: WGS 84 Annual Crop Rootzone (cm): 70 Landuse: Rangeland Grazing
 Easting: 528830 Northing: 6280450 Plant Available Water (mm): 104 Surface condition: Hardset
 Surface Elevation(m): 48.1 Drainage: Moderately well drained Surface gravel: None
 Equipment: Christie corer Estimated Permeability: 5 to 50 mm/day Outcrop: None

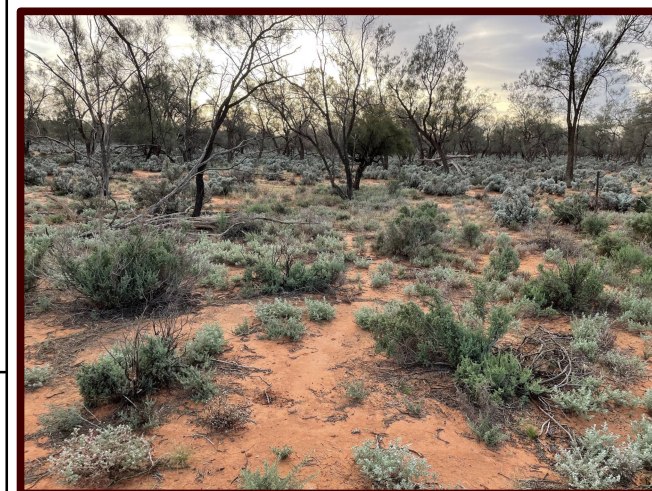
TEST HOLE SC2084

Date Excavated: 19/5/22 Australian Soil Class: Supracalcic Calcarosol Geology: Aeolian sand plain
Logged by: PJH Datum: WGS 84 Annual Crop Rootzone (cm): 70 Landuse: Rangeland Grazing
Easting: 528831 Northing: 6280005 Plant Available Water (mm): 116 Surface condition: Cryptogram Crust
Surface Elevation(m): 51.1 Drainage: Moderately well drained Surface gravel: None
Equipment: Christie corer Estimated Permeability: 5 to 50 mm/day Outcrop: None

DEPTH (centimetres)	Horizon	GRAPHIC LOG	PROFILE DESCRIPTION	Field pH	Moisture	Efferves- cence	Approximate Concretions	Field ECe (dS/m)	SAMPLE
	A		Red loam, fine sandy with weak grade of subangular blocky structure and ped size of cm breaking to cm. Soil is slightly dispersive, completely slakes	8	Moist	Very high			
50	B1		Red loam with weak grade of polyhedral structure and ped size of cm breaking to cm. Soil is not dispersive, doesn't slake	8	Moist	Very high	2% Carb	19.5	
	B21k		Red fine sandy clay loam with weak grade of polyhedral structure and ped size of cm breaking to cm. Soil is not dispersive, completely slakes	9	Dry	Very high	50% Carb		
100	B22tk		Red light clay with weak grade of polyhedral structure and ped size of cm breaking to cm. Soil is not dispersive, completely slakes	9	Dry	Very high	60% Carb	12.6	
150			COMMENTS: 100 m north of crest, Belah around this patch that was scalded now stabilised.

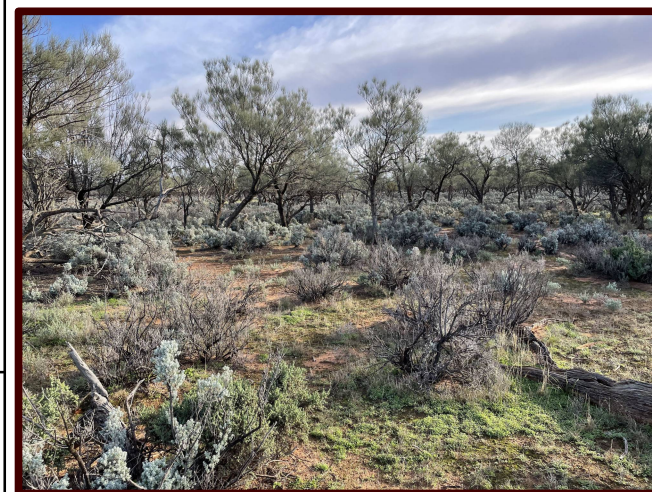
TEST HOLE SC2085

Date Excavated: 19/5/22 Australian Soil Class: Supracalcic Calcarosol Geology: Aeolian sand plain
Logged by: PJH Datum: WGS 84 Annual Crop Rootzone (cm): 60 Landuse: Rangeland Grazing
Easting: 530828 Northing: 6282278 Plant Available Water (mm): 47 Surface condition: Cryptogram Crust
Surface Elevation(m): 47.4 Drainage: Moderately well drained Surface gravel: None
Equipment: Christie corer Estimated Permeability: 5 to 50 mm/day Outcrop: None

DEPTH (centimetres)	Horizon	GRAPHIC LOG	PROFILE DESCRIPTION	Field pH	Moisture	Efferves- cence	Approximate Concretions	Field ECe (dS/m)	SAMPLE
	A		Red loam, fine sandy with weak grade of angular blocky structure. Soil is not dispersive, completely slakes	8	Moist	Very high			
50	B22k		Red fine sandy clay loam with moderate grade of polyhedral structure. Soil is not dispersive, completely slakes	9	Dry	Very high	50% Carb	10	
100	B23k		Red light clay with strong grade of polyhedral structure. Soil is not dispersive, completely slakes	9	Dry	High	20% Carb		
150	B3y		Red light clay with strong grade of polyhedral structure. Soil is not dispersive, completely slakes	9	Dry	Very high	50% Gyp	14	
COMMENTS: Surface condition - 60% Cryptogram Crust, 40% Hardset. Bottom of hole at 140

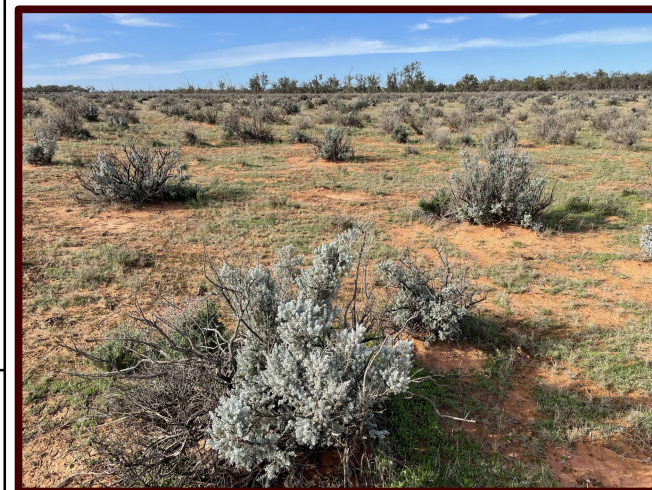
TEST HOLE SC2090

Date Excavated: 15/11/23 Australian Soil Class: Hypercalcic Calcarosol Geology: Aeolian lunette with kopi
 Logged by: PJH Datum: WGS 84 Annual Crop Rootzone (cm): 70 Landuse: Naturalised pasture
 Easting: 531072 Northing: 6275727 Plant Available Water (mm): 145 Surface condition: Cryptogram crust
 Surface Elevation(m): 30.4 Drainage: Well drained Surface gravel: None
 Equipment: Christie Estimated Permeability: 50 to 500 mm/day Outcrop: None

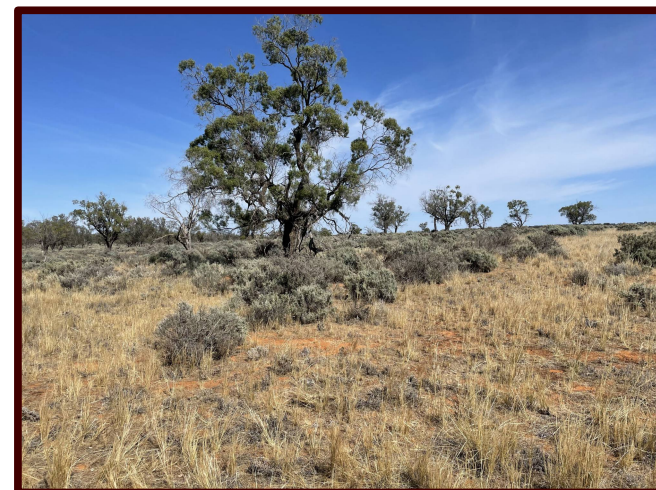
TEST HOLE SC2091

Date Excavated: 15/11/23 Australian Soil Class: Hypercalcic Calcarosol Geology: Aeolian sand plain
 Logged by: PJH Datum: WGS 84 Annual Crop Rootzone (cm): 70 Landuse: Naturalised pasture
 Easting: 531230 Northing: 6275393 Plant Available Water (mm): 140 Surface condition: Cryptogram crust
 Surface Elevation(m): 33.2 Drainage: Moderately well drained Surface gravel: None
 Equipment: Christie Estimated Permeability: 5 to 50 mm/day Outcrop: None

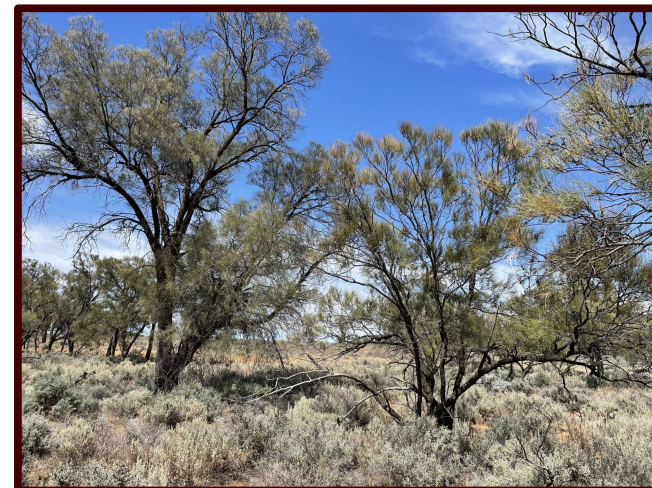
TEST HOLE SC2092

Date Excavated: 15/11/23 Australian Soil Class: Hypercalcic Calcarosol Geology: Aeolian sand plain
 Logged by: PJH Datum: WGS 84 Annual Crop Rootzone (cm): 30 Landuse: Naturalised pasture
 Easting: 531048 Northing: 6274832 Plant Available Water (mm): 41 Surface condition: Cryptogram crust
 Surface Elevation(m): 33.3 Drainage: Imperfectly drained Surface gravel: None
 Equipment: Christie Estimated Permeability: 5 to 50 mm/day Outcrop: None

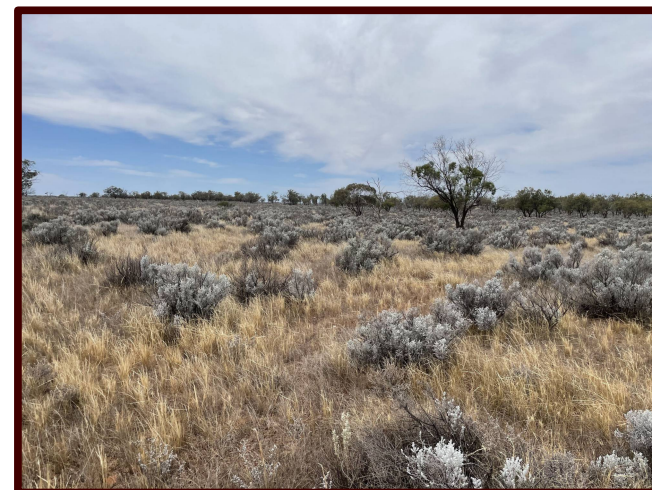
TEST HOLE SC2093

Date Excavated: 15/11/23 Australian Soil Class: Hypercalcic Calcarosol Geology: Aeolian sand plain
Logged by: PJH Datum: WGS 84 Annual Crop Rootzone (cm): 50 Landuse: Naturalised pasture
Easting: 530434 Northing: 6274687 Plant Available Water (mm): 77 Surface condition: Cryptogram crust
Surface Elevation(m): 37.2 Drainage: Imperfectly drained Surface gravel: None
Equipment: Christie Estimated Permeability: 5 to 50 mm/day Outcrop: None

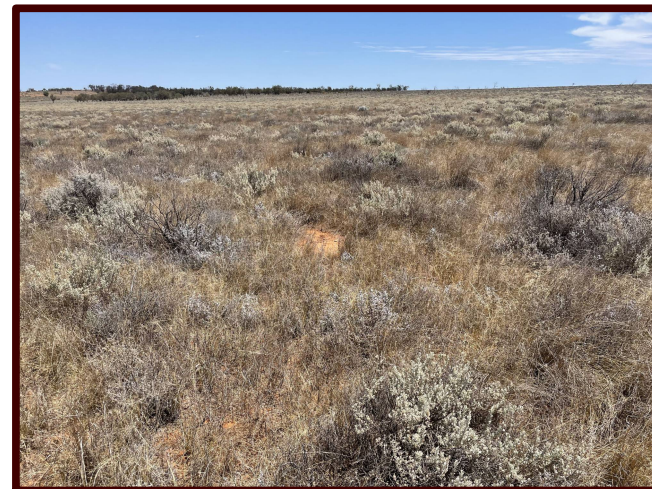
TEST HOLE SC2094

Date Excavated: 15/11/23 Australian Soil Class: Hypercalcic Calcarosol Geology: Aeolian sand plain
Logged by: PJH Datum: WGS 84 Annual Crop Rootzone (cm): 70 Landuse: Naturalised pasture
Easting: 530129 Northing: 6274805 Plant Available Water (mm): 150 Surface condition: Cryptogram crust
Surface Elevation(m): 44.9 Drainage: Well drained Surface gravel: None
Equipment: Christie Estimated Permeability: 50 to 500 mm/day Outcrop: None

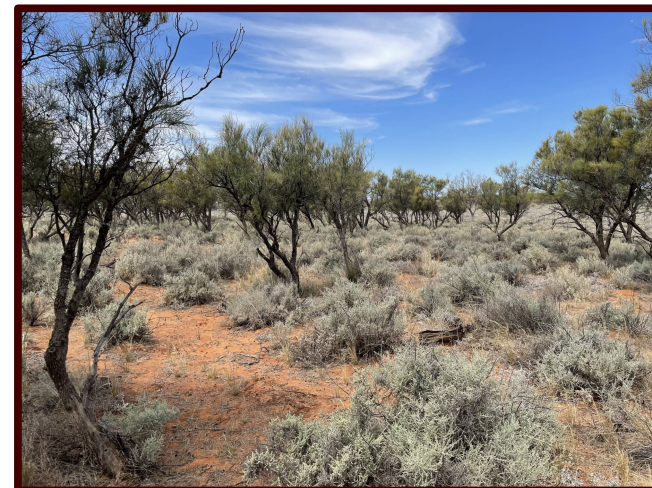
TEST HOLE SC2095

Date Excavated: 15/11/23 Australian Soil Class: Hypercalcic Calcarosol Geology: Aeolian lunette
Logged by: PJH Datum: WGS 84 Annual Crop Rootzone (cm): 50 Landuse: Naturalised pasture
Easting: 533347 Northing: 6275670 Plant Available Water (mm): 70 Surface condition: Hardset
Surface Elevation(m): 34.1 Drainage: Well drained Surface gravel: None
Equipment: Christie Estimated Permeability: 50 to 500 mm/day Outcrop: None

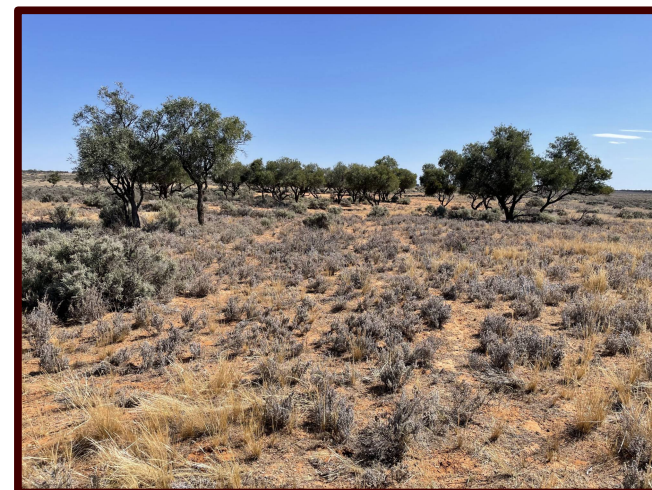
TEST HOLE SC2096

Date Excavated: 16/11/23 Australian Soil Class: Red Chromosol Geology: Woorinen Formation
 Logged by: PJH Datum: WGS 84 Annual Crop Rootzone (cm): 50 Landuse: Naturalised pasture
 Easting: 532674 Northing: 6272835 Plant Available Water (mm): 87 Surface condition: Cryptogram crust
 Surface Elevation(m): 39.2 Drainage: Moderately well drained Surface gravel: None
 Equipment: Christie Estimated Permeability: 5 to 50 mm/day Outcrop: None

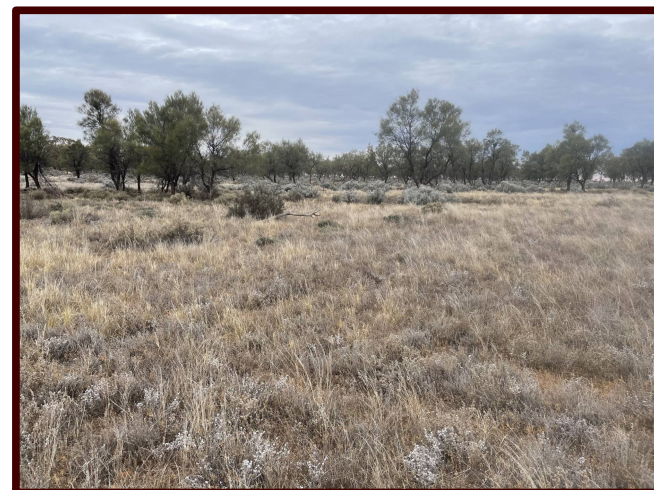
TEST HOLE SC2097

Date Excavated: 16/11/23 Australian Soil Class: Brown Kandosol Geology: Aeolian lunette with kopi
Logged by: PJH Datum: WGS 84 Annual Crop Rootzone (cm): 30 Landuse: Naturalised pasture
Easting: 533273 Northing: 6274335 Plant Available Water (mm): 24 Surface condition: Hardset
Surface Elevation(m): 31.5 Drainage: Well drained Surface gravel: None
Equipment: Christie Estimated Permeability: > 500 mm/day Outcrop: None

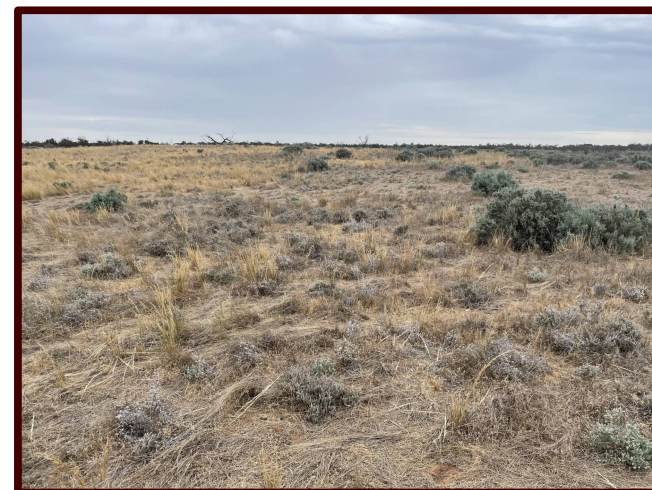
TEST HOLE SC2098

Date Excavated: 16/11/23 Australian Soil Class: Hypergyptic Calcarosol Geology: Yamba Formation
 Logged by: PJH Datum: WGS 84 Annual Crop Rootzone (cm): 20 Landuse: Naturalised pasture
 Easting: 533026 Northing: 6274608 Plant Available Water (mm): 17 Surface condition: Cryptogram crust
 Surface Elevation(m): 27.4 Drainage: Imperfectly drained Surface gravel: None
 Equipment: Christie Estimated Permeability: < 5 mm/day Outcrop: None

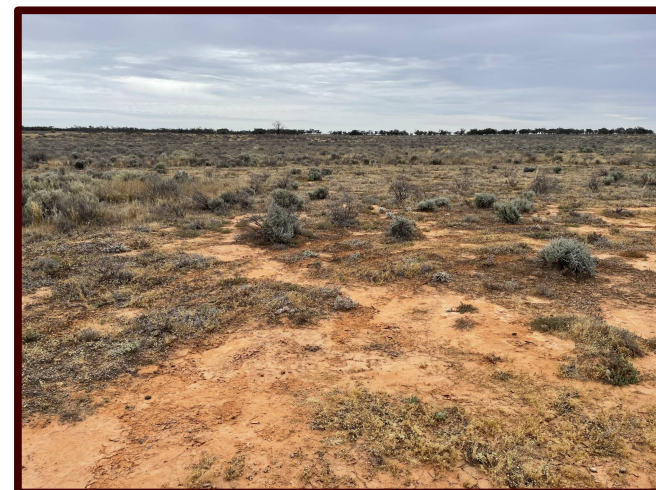
TEST HOLE SC2099

Date Excavated: 16/11/23 Australian Soil Class: Hypercalcic Calcarosol Geology: Woorinen Formation
Logged by: PJH Datum: WGS 84 Annual Crop Rootzone (cm): 80 Landuse: Naturalised pasture
Easting: 537330 Northing: 6278749 Plant Available Water (mm): 103 Surface condition: Cryptogram crust
Surface Elevation(m): 50.7 Drainage: Imperfectly drained Surface gravel: None
Equipment: Christie Estimated Permeability: 5 to 50 mm/day Outcrop: None

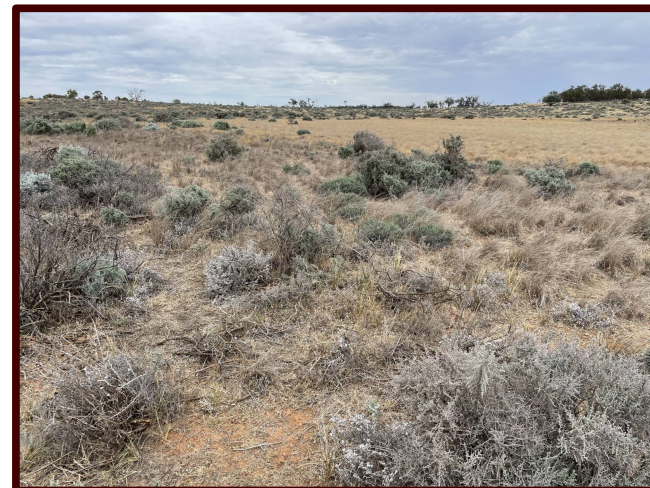
TEST HOLE SC2100

Date Excavated: 16/11/23 Australian Soil Class: Brown Chromosol Geology: Woorinen Formation
 Logged by: PJH Datum: WGS 84 Annual Crop Rootzone (cm): 70 Landuse: Naturalised pasture
 Easting: 537409 Northing: 6279547 Plant Available Water (mm): 58 Surface condition: Loose
 Surface Elevation(m): 52.9 Drainage: Moderately well drained Surface gravel: None
 Equipment: Christie Estimated Permeability: 5 to 50 mm/day Outcrop: None

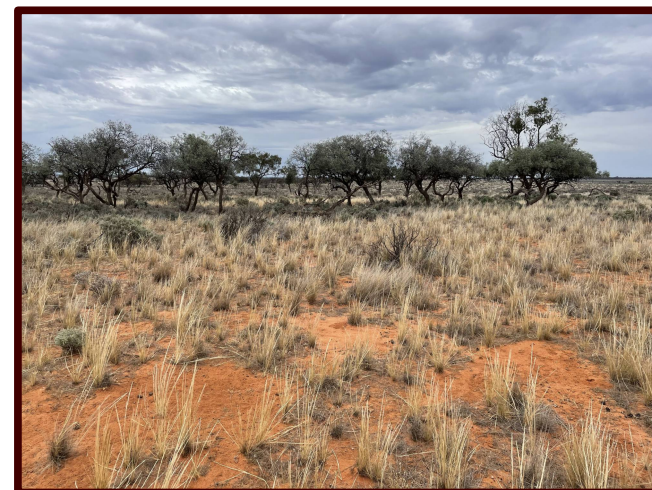
TEST HOLE SC2101

DEPTH (centimetres)	Horizon	GRAPHIC LOG	PROFILE DESCRIPTION	Field pH	Effervescence	Carbonate Class	Approximate Concretions	Field ECe (dS/m)	SAMPLE
	A		Red light clay with strong grade of subangular blocky structure and ped size of 5 cm breaking to 1 cm. Soil is not dispersive, completely slakes, has a moderate to good SOILpak score and has abundant roots present.	9	Very high				
	B1		Brown light clay with strong grade of prismatic structure and ped size of cm breaking to cm. Soil is slightly dispersive, completely slakes, has a moderate to good SOILpak score and has an average number of roots present.	8.5	Very high		5% Carb	6	
50	B22		Red light medium clay with strong grade of polyhedral structure and ped size of cm breaking to cm. Soil is not dispersive, partially slakes, has a moderate SOILpak score and has an average number of roots present.	8.5	Very high		20% Carb		
100	B23		Brown light medium clay with strong grade of polyhedral structure and ped size of cm breaking to cm. With 10% G mottle. Soil is not dispersive, partially slakes, has a moderate SOILpak score and has no roots present.	8	Very high		20% Gyp	18.9

150			COMMENTS: Slickensides in B23. Trace mangans in B23. Only B23 is poorly drained. Site in floor of broad drainage line. Bottom of hole at 120

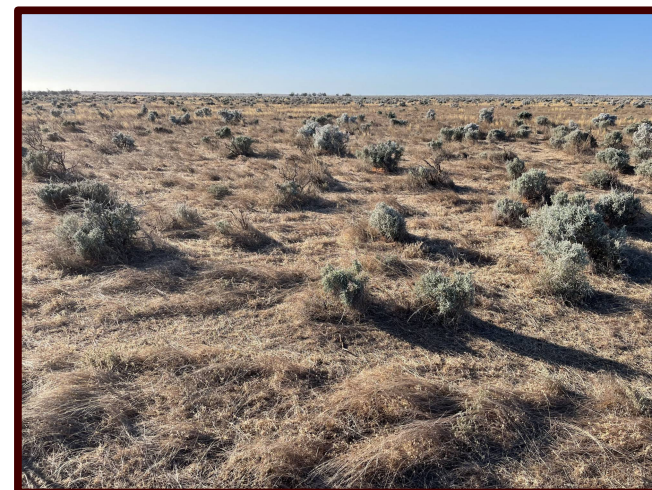
TEST HOLE SC2105

Red sandy clay with strong grade of polyhedral structure and ped size of cm breaking to cm. Soil is not dispersive, completely slakes, has a moderate SOILpak score and has few roots present.	8	Very high		20% Carb	13

150			COMMENTS: Above scalded drainage lines that channel water towards Lake Floor East Bottom of hole at 120
